BPG Inspection Services

**1355 Stark Strasse
Ann Arbor MI 48105**

Client(s): Kahn
Inspection Date: 5/17/2019
Inspector: Rick Bowling, LIC #

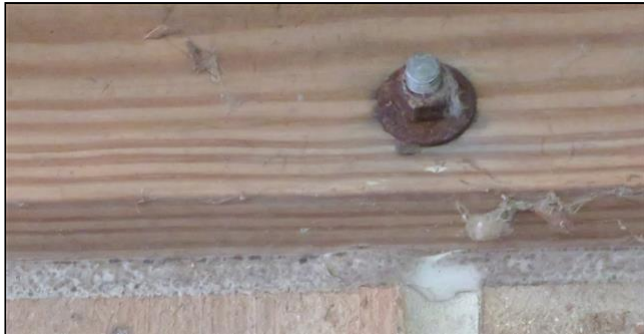
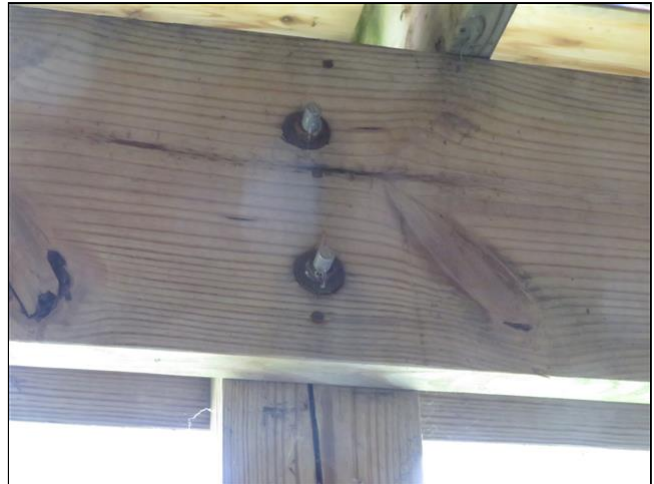
1. Rusted fasteners should be replaced.

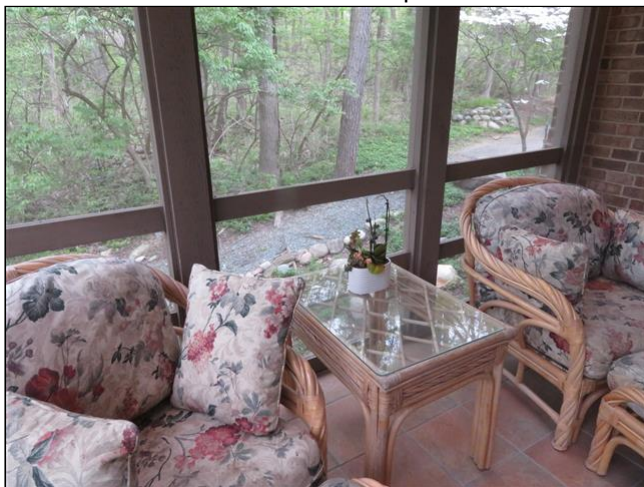
Item 2 - Picture 1

2. The screened room lacks an adequate fall barrier. Have corrected as needed.

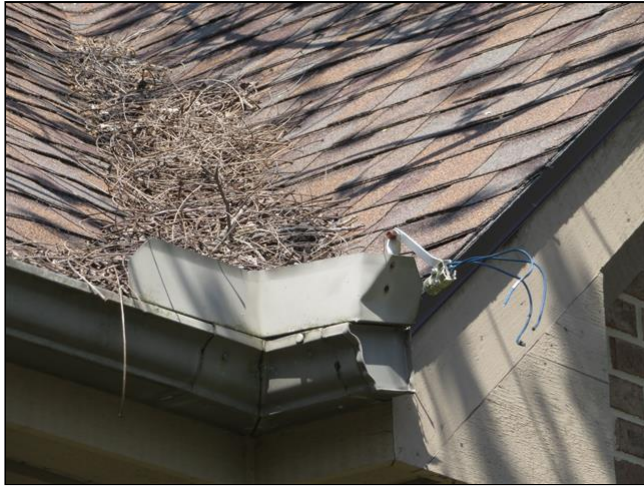
Item 3 - Picture 1

3. Debris in valleys and gutters should be cleaned to reduce risk of leaks.

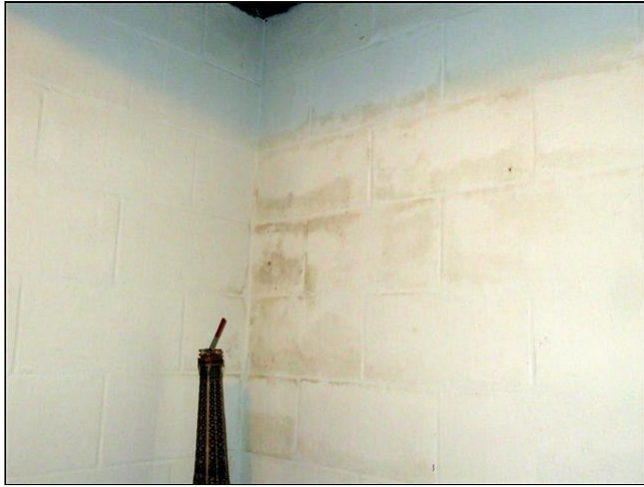
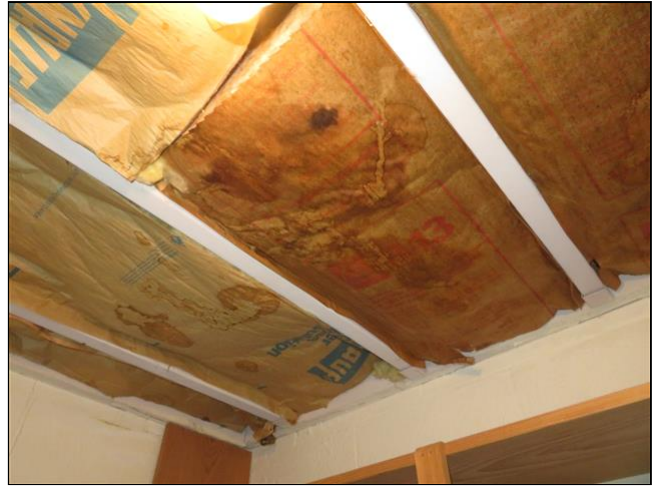
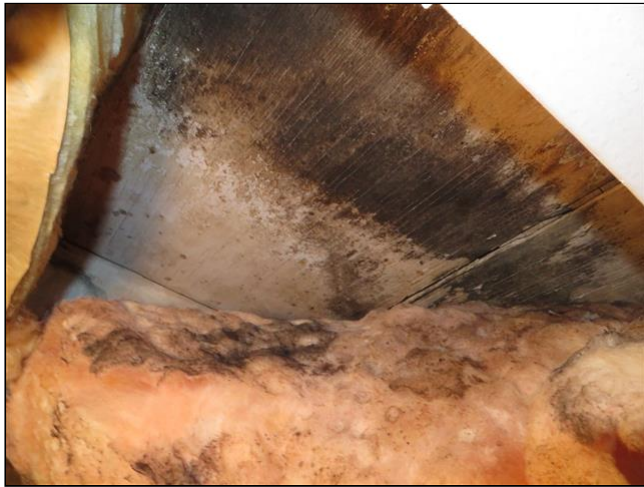
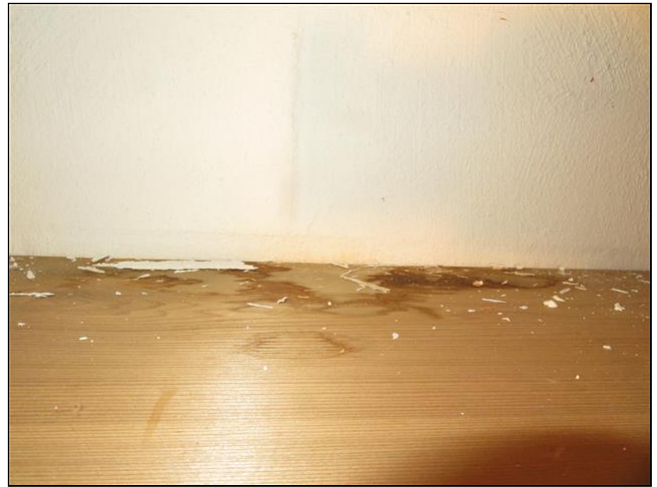
- 4. Some water stains noted on the foundation wall in the train room as well as at the ceiling under the front porch where mold was also found. We advise having reviewed and corrected as needed.

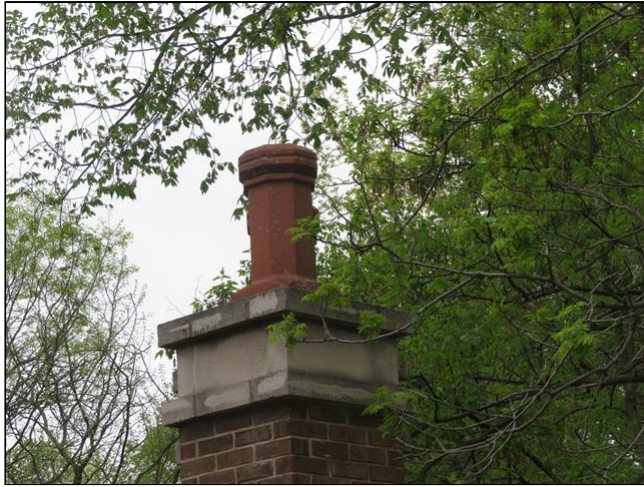
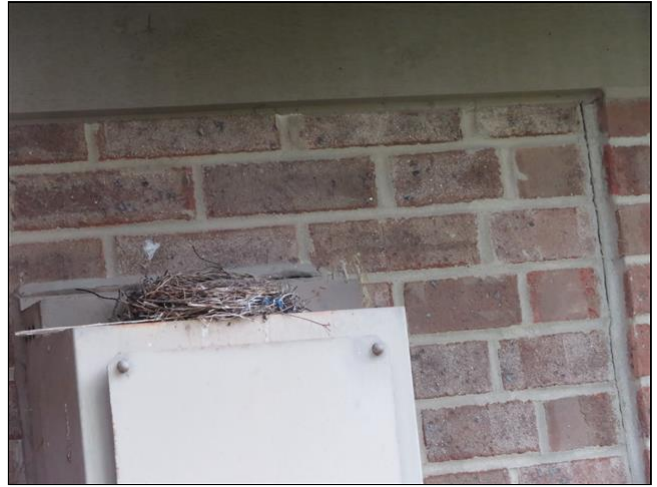
5. We suggest installing a spark arrestor and rain cap on the each chimney flue. This helps prevent water and pest intrusion.

We suggest trimming vegetation well away from the structure to provide free airflow, and proper draft and to reduce chances of damage and allow for routine observation and maintenance.

One of the gas fireplace vents has an active bird nest. Have the vents cleaned before use by a qualified fireplace specialist to reduce risk of carbon monoxide entering the structure.

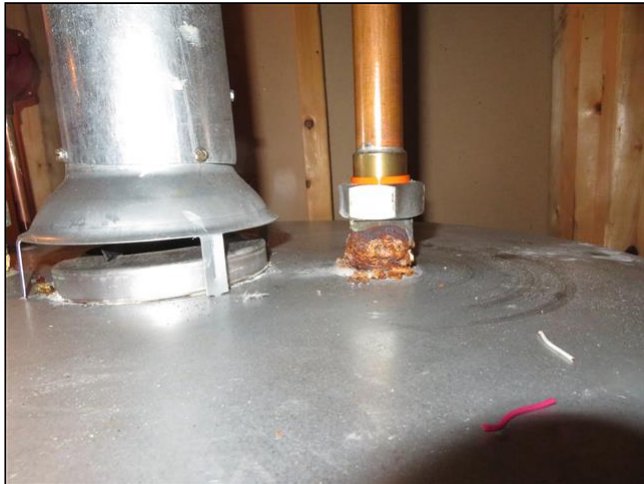
Item 7 - Picture 1

- ❌ 7. Corroded plumbing over the tank should be repaired to prevent leaks and further damage.

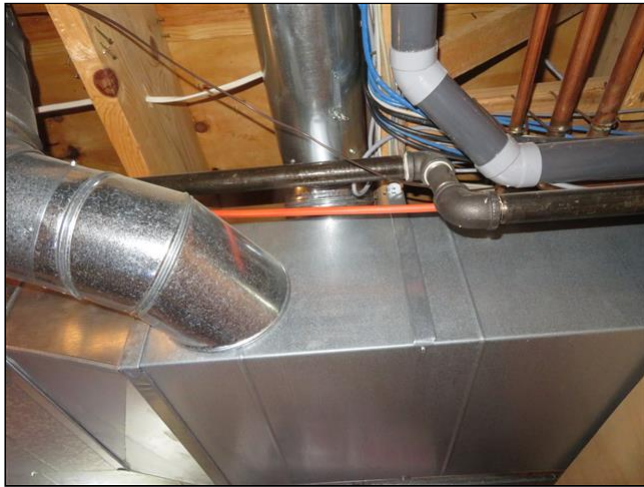
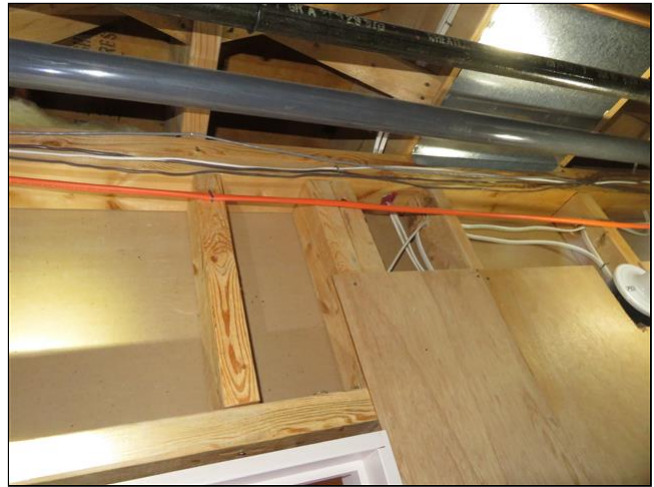
- ❌ 9. Exposed wiring at the basement should be corrected as needed and protected from physical damage to help assure safe function.

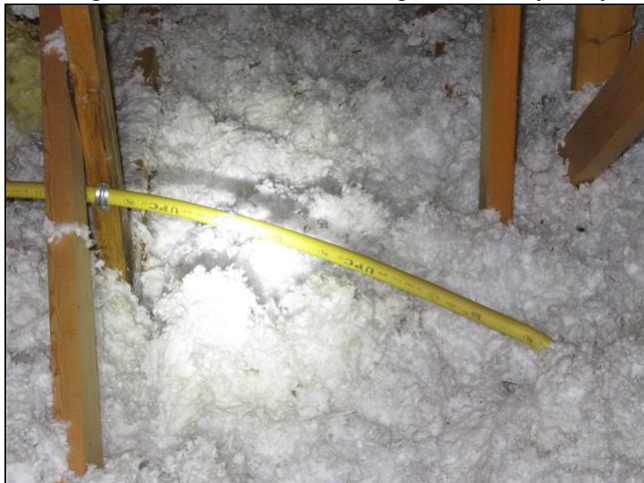
Item 10 - Picture 1

- ❌ 10. The corrugated stainless steel tubing (CSST) should be bonded to the electrical service grounding electrode system. This is a fairly recent requirement in order to reduce the chances of a natural gas leak or fire. More information is available here <http://www.csstsafety.com/CSST-solution.html> or by searching the web for "CSST Bonding". In most cases, bonding is relatively easy to achieve.

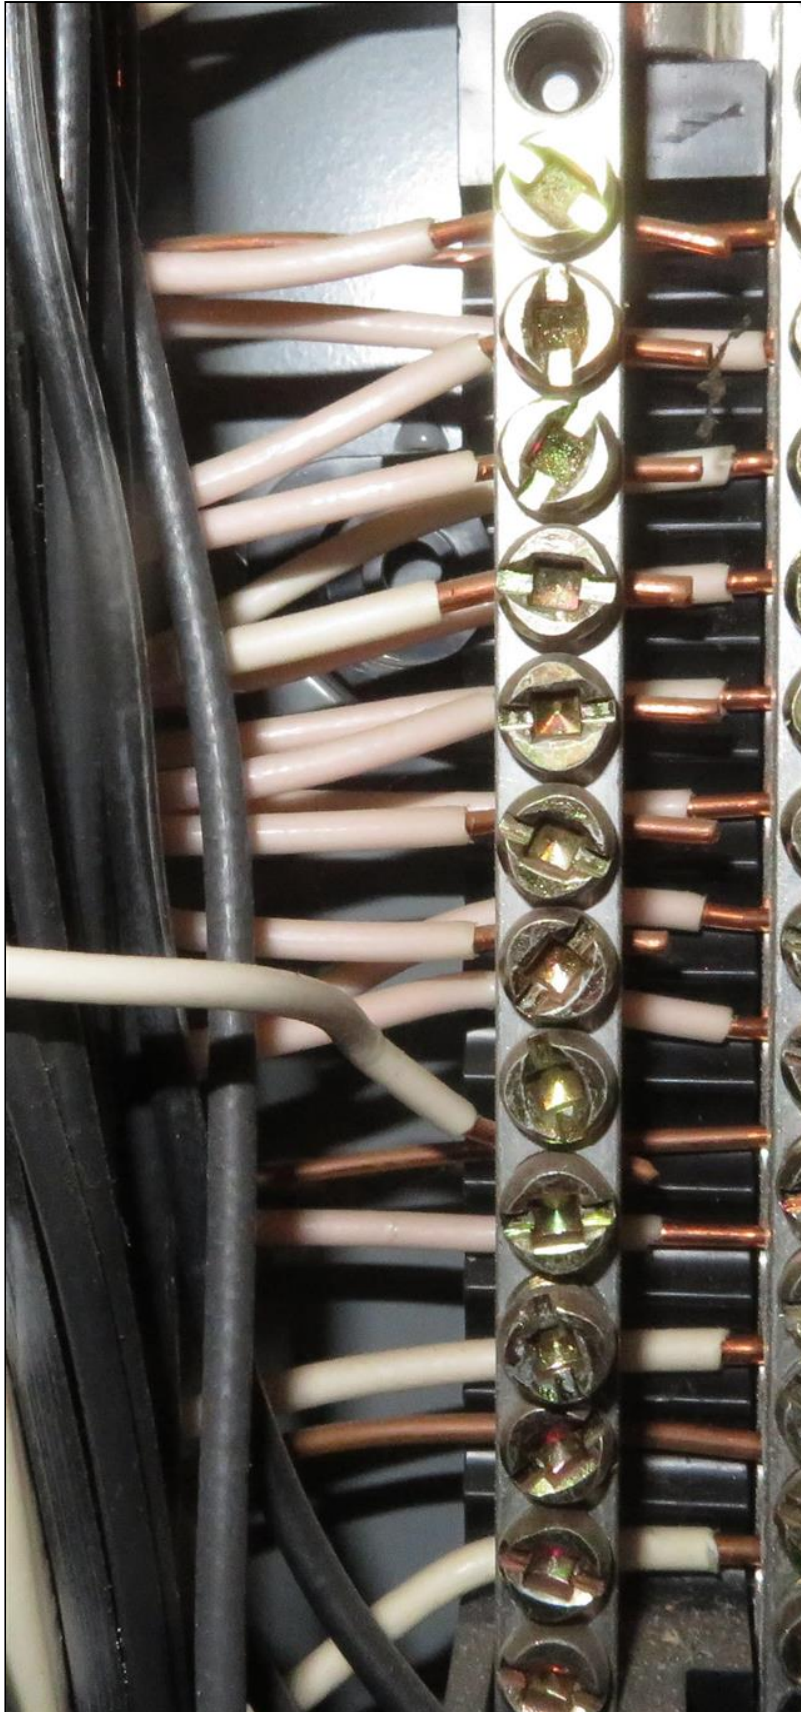
Item 11 - Picture 1

- ❌ 11. In the left basement service panel, some grounding wires have been improperly attached to the neutral bus. Have an electrician correct for safety. This is an easy but important repair.

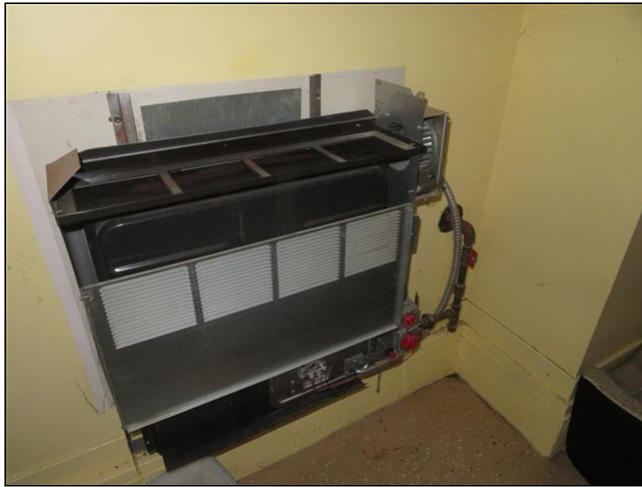
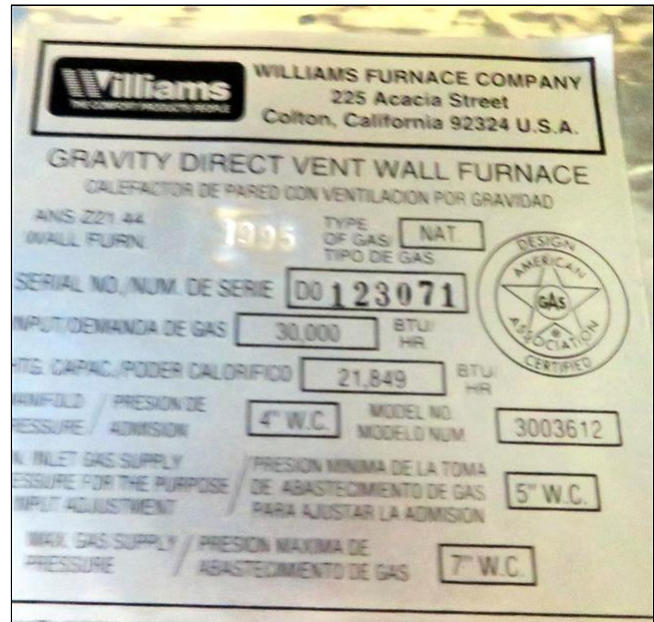
- ❌ 12. The furnaces and one air conditioner are old and could require repair or replacement at any time.
- ❌ 13. We were unable to light pilot on wall heater in garage and suggest having serviced by a qualified heating contractor.

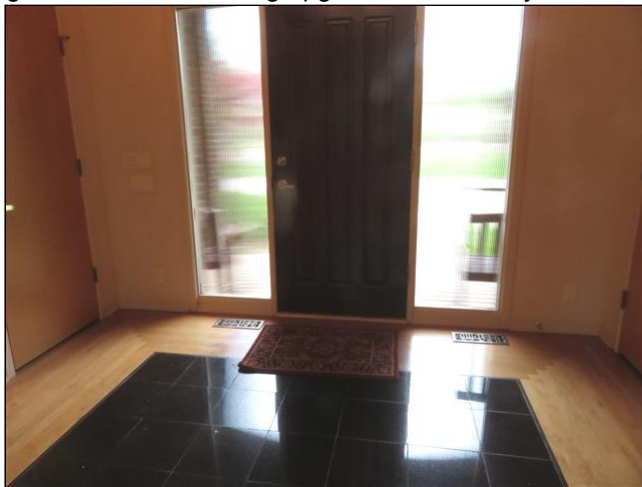
Item 14 - Picture 1

- ❌ 14. There is no safety glass label visible at the windows by the entry door. If the glass can not be verified as safety glass we advise having upgraded as a safety enhancement.

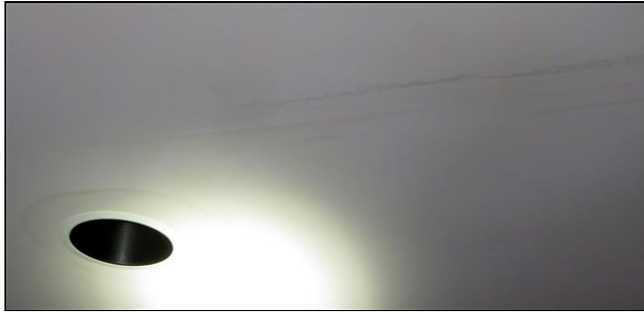
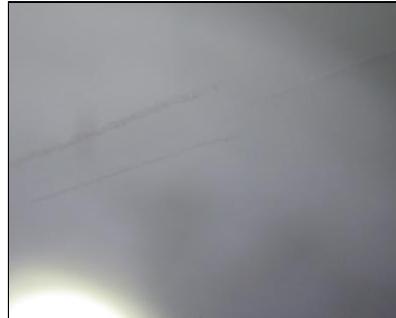
- ☒ 15. Water stains are visible on the basement ceiling, under the master suite. We suggest having the source of water determined and repairs made as needed. Note that the steam unit was not tested during the inspection as the breaker was shut off.

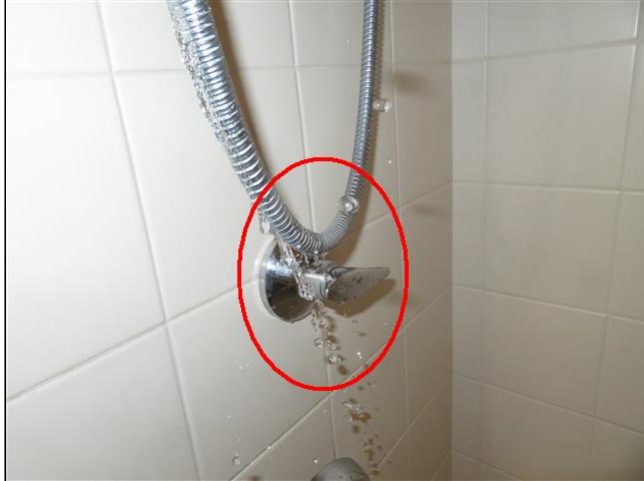
Item 17 - Picture 1

- ☒ 17. The shower diverter at one of the basement baths is difficult to operate and needs repair.

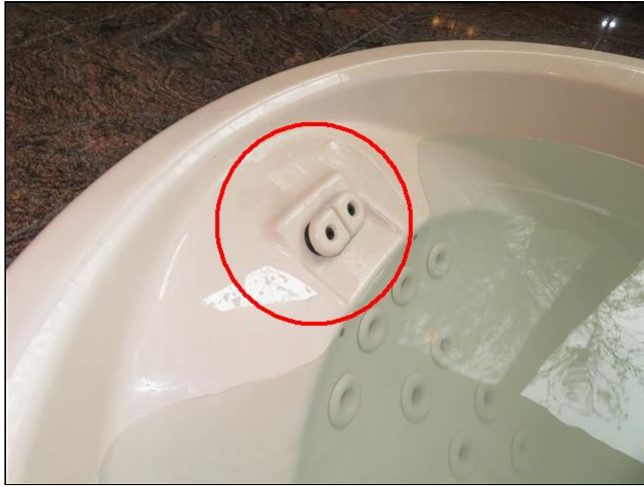
Item 18 - Picture 1

- ☒ 18. Pump operable but we were unable to turn off neck jets (they have their own switch). The jets can't be turned on without spraying water out of the tub until corrected. Have adjusted/repared as needed.

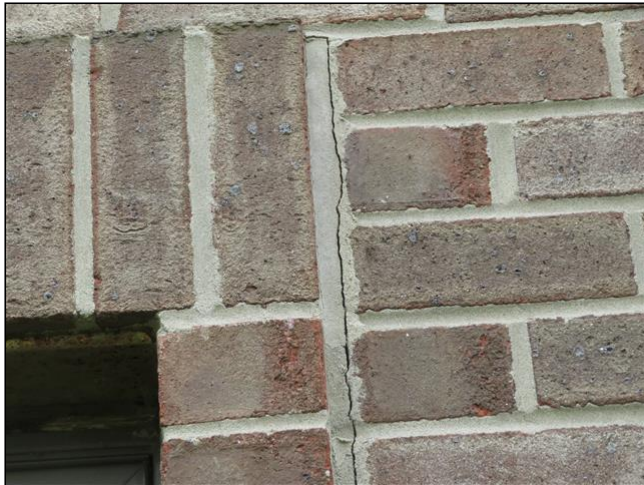
Item 22 - Picture 1

22. Some thin cracking in the masonry needs sealing.

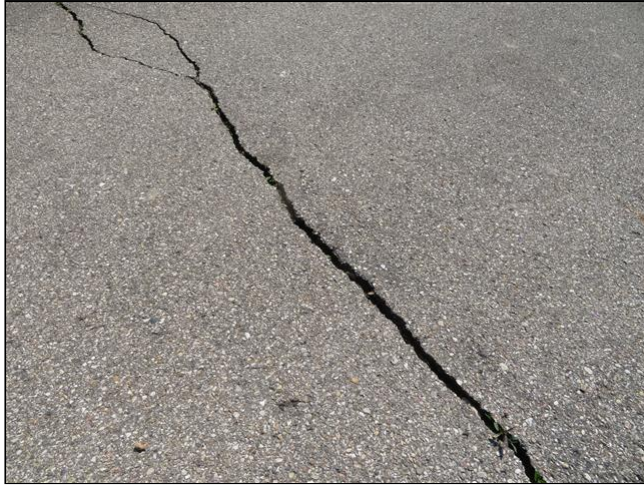
Item 24 - Picture 1

24. We suggest filling cracks to help extend the life of the pavement.

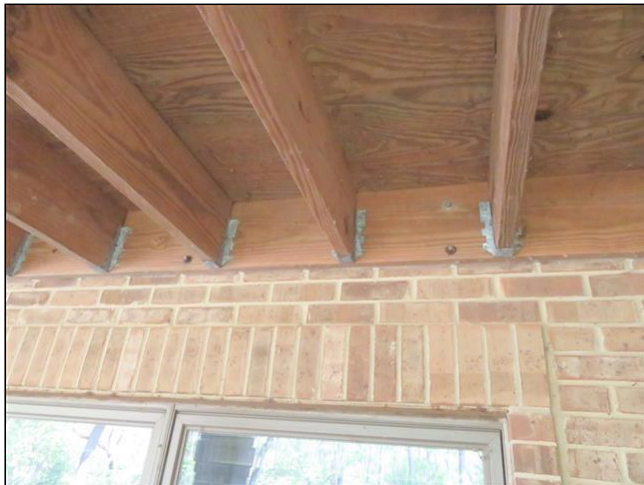
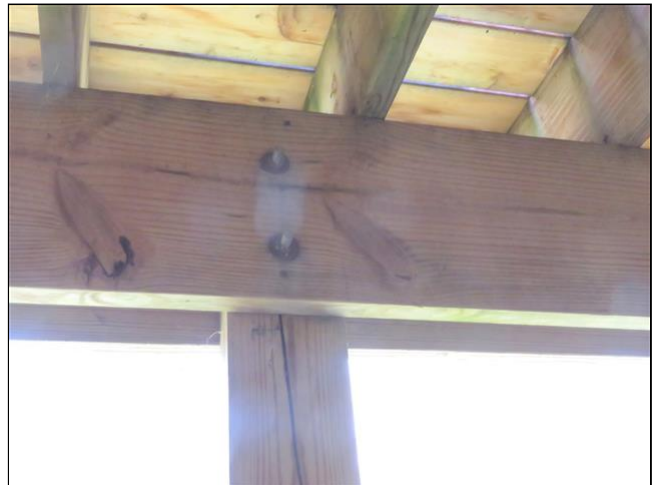
25. The deck is partially supported by attachment through the brick veneer wall. This is a common practice that has been approved by many building departments until recently. In many cases this performs as intended. However, this type of attachment has been found to be prone to concealed water intrusion. Also, since brick veneer is non-structural, there is increased risk of the brick coming loose. This is particularly a concern for tall and or large decks as well as decks where groups are entertained. We suggest having sealed and resupported as needed.

The decking is also supported by a type of beam connection that may be prone to failure. Wood joists are fastened on each side of posts. This relies on the fasteners for support rather than the lumber. We suggest having resupported to help assure proper performance and reduce the risk of damage.

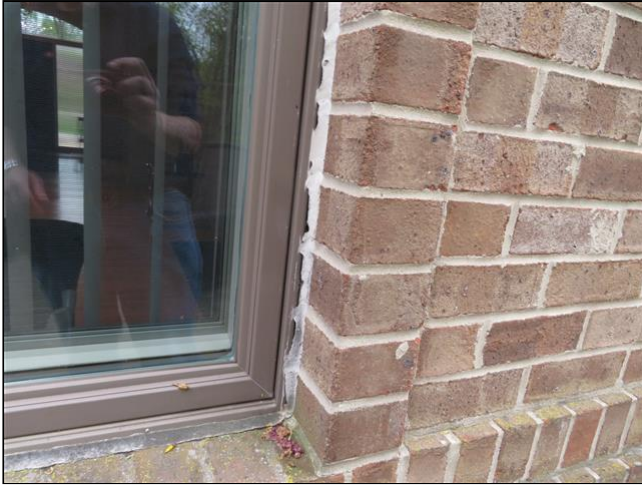
Item 27 - Picture 1

- ☒ 27. We suggest caulking/sealing the exterior as needed to help shed water and to maximize energy efficiency. Pay attention to all openings and gaps as well as old caulk that has deteriorated.

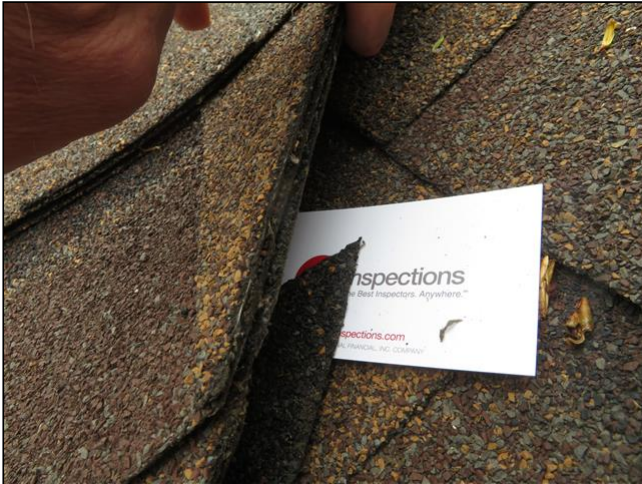
Item 28 - Picture 1

- ☒ 28. The valley shingles were not all trimmed according to roofing specifications. The upper corner of each end shingle should be trimmed on a 45 degree angle to direct water into the valley and discourage water flow under the shingle surface. In many cases, no leaks occur, but as a precaution, we advise having corrected to help shed water.

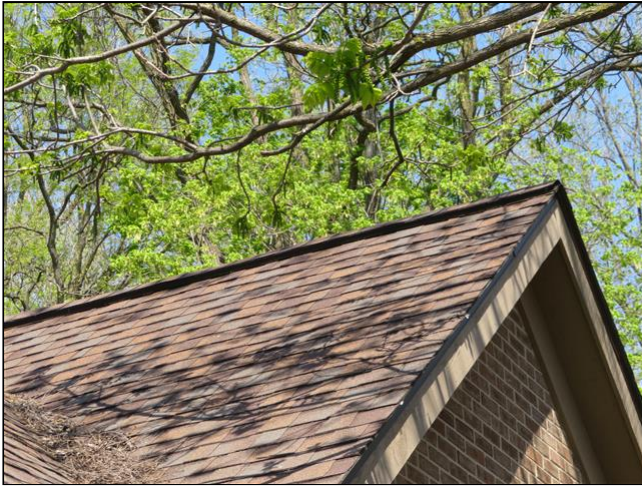
Item 30 - Picture 1

- ☒ 30. Vegetation should be trimmed away from the roof as it can damage the roof surface and structure.

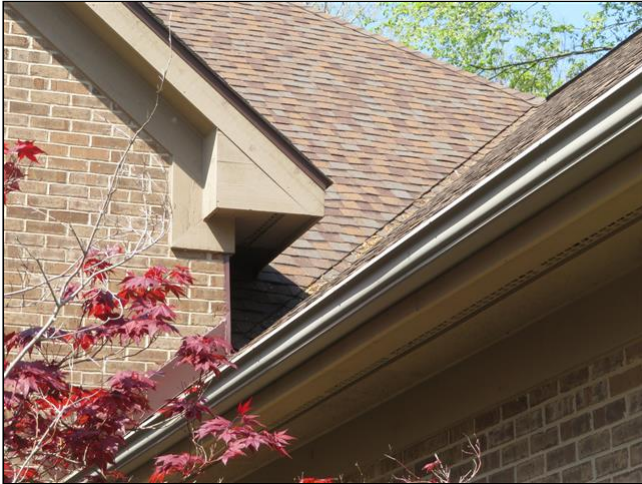
Item 31 - Picture 1

31. Areas where the roof slopes towards the structure are prone to water intrusion and ice damming and should be monitored closely for leaks and maintenance as needed. Leaks might not be apparent except when actually occurring. Because of the nature of construction, important portions of the flashing are concealed from view

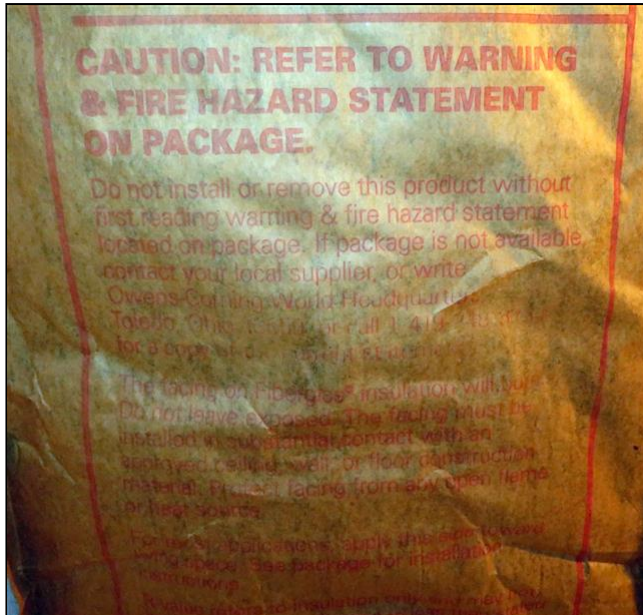
Item 33 - Picture 1

33. The vapor retarder on some insulation is exposed, contrary to the manufacturer's instructions. The vapor barrier is flammable and should be covered and should face the heated space.

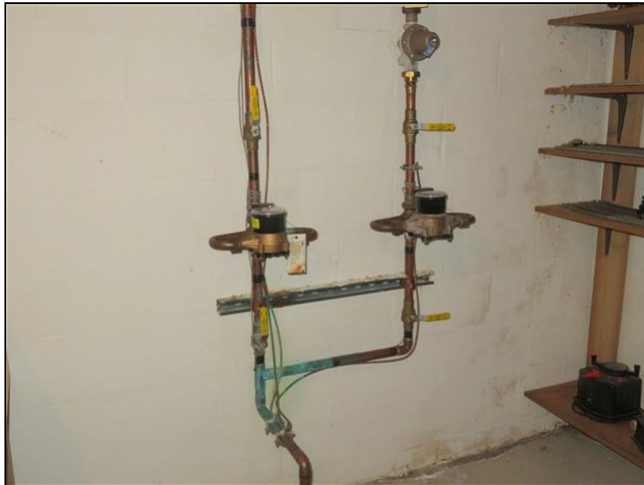
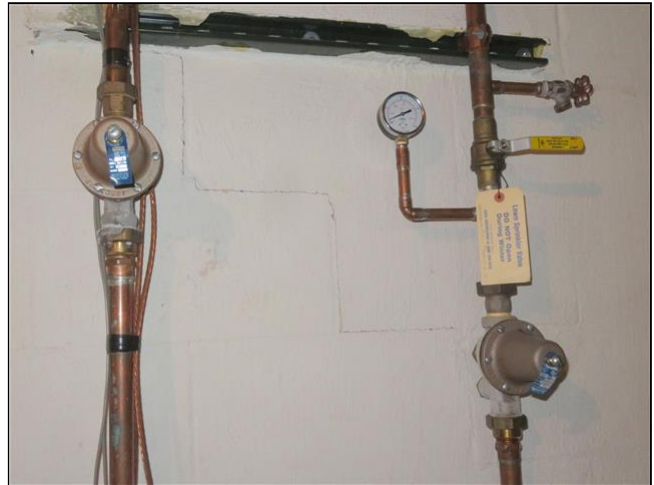
- ☒ 35. Corroded plumbing should be cleaned and checked for needed maintenance.

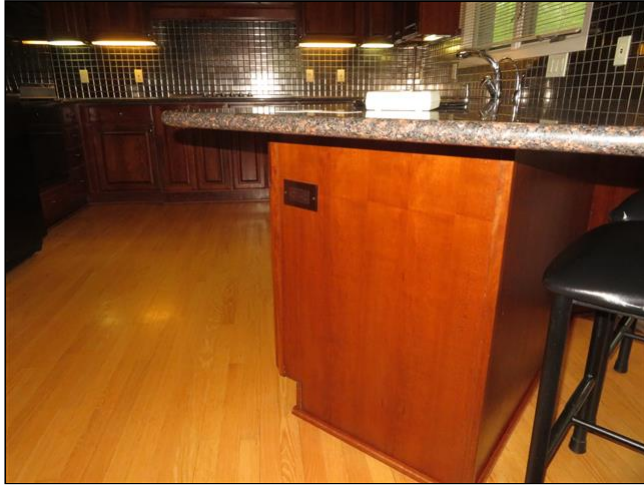
Item 37 - Picture 1

- ☒ 37. Outlets under countertops can be a hazard when corded appliances are plugged in and dangle over the counter. We suggest covering the outlet or at least not using this outlet for any counter mounted appliance.

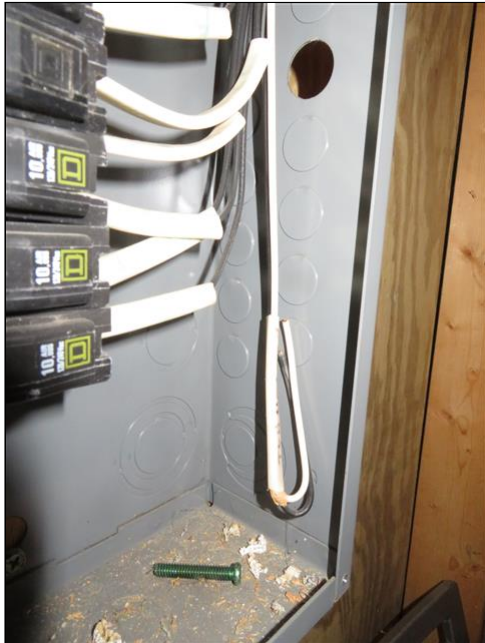
Item 38 - Picture 1

- ☒ 38. Open knockouts should be appropriately sealed for safety and to help prevent pest intrusion. Plugs are typically widely available and inexpensive. Cut off wiring should be properly terminated with wire nuts.

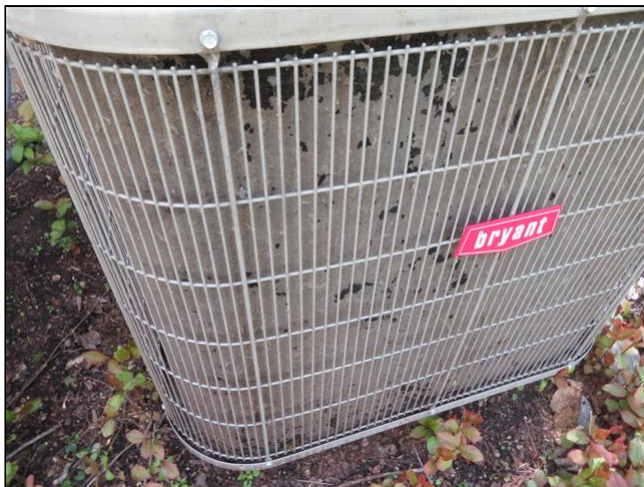
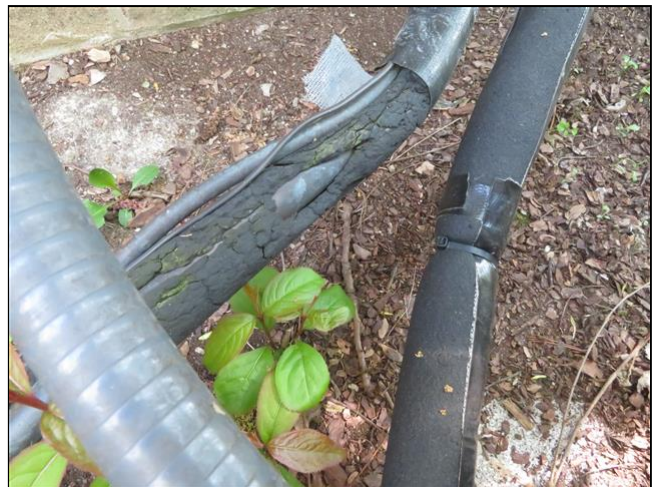
- ☒ 41. The air conditioner fins are dirty and should be cleaned to improve the unit's efficiency and reduce stress on the unit. (Typically this can be done with a garden hose on high pressure).

The insulation on the suction line is deteriorated at the outside unit. Missing insulation on a suction line can cause energy loss and condensation. New insulation should be installed. This is an easy repair.

Vegetation should be trimmed at least two feet away from the exterior air conditioning unit(s) to avoid excess wear and increase efficiency.

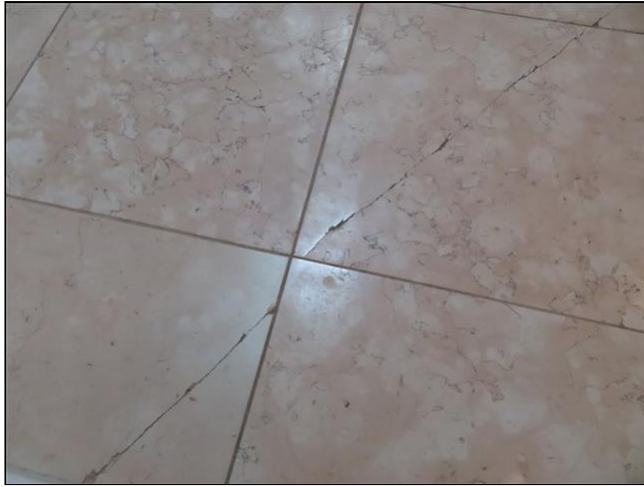
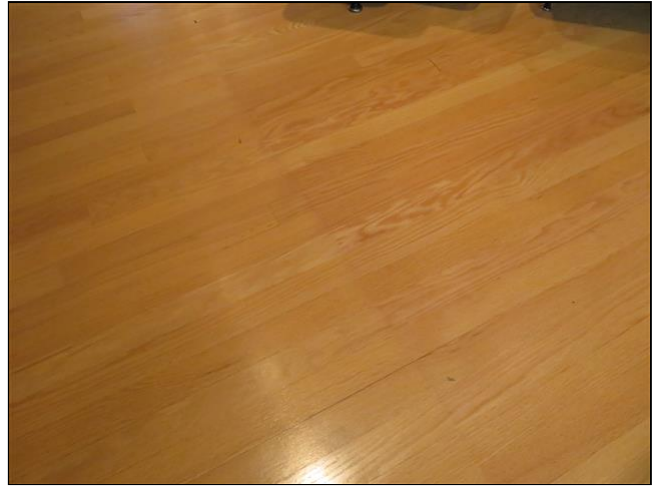
- ☒ 42. Some thin tile cracking noted and areas of cosmetic damage at wood floors.

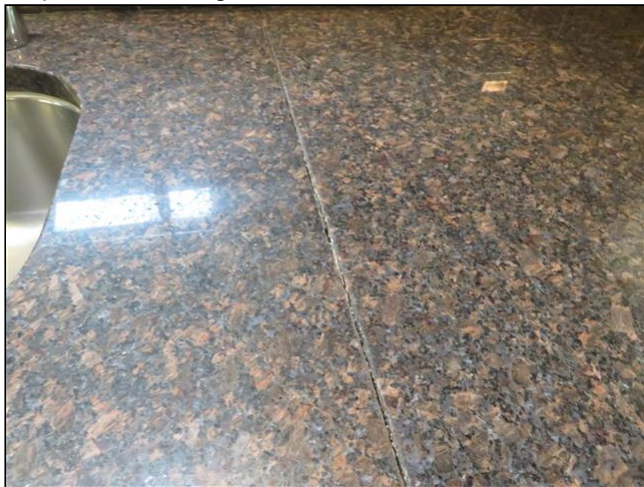
Item 46 - Picture 1

46. Gap needs sealing.
