## BPG Inspection Services

Client(s): Kahn  
Inspection Date: 5/17/2019  
Inspector: Rick Bowling, LIC #

<b>Date:</b> 5/17/2019	<b>Time:</b> 01:00:00 PM	<b>Report ID:</b> 755342
<b>Property:</b> 1355 Stark Strasse, Ann Arbor, MI 48105		<b>Prepared By:</b> Rick Bowling

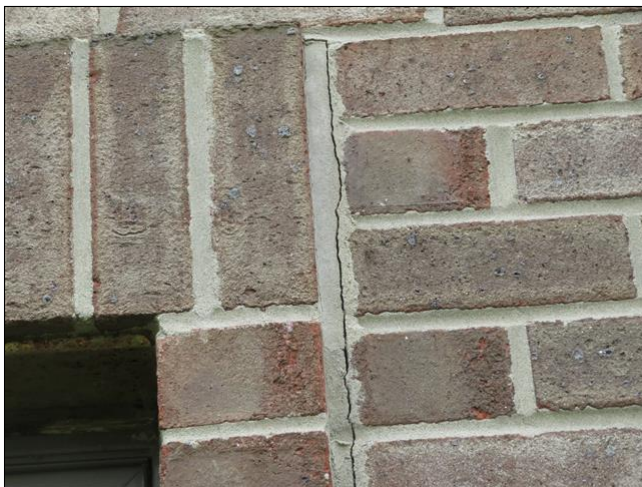
♦ Some thin cracking in the masonry needs sealing.

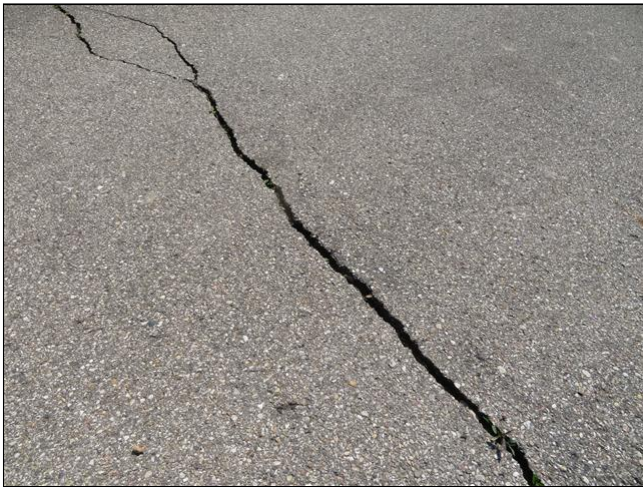
- ⏏ ♦ We suggest filling cracks to help extend the life of the pavement.

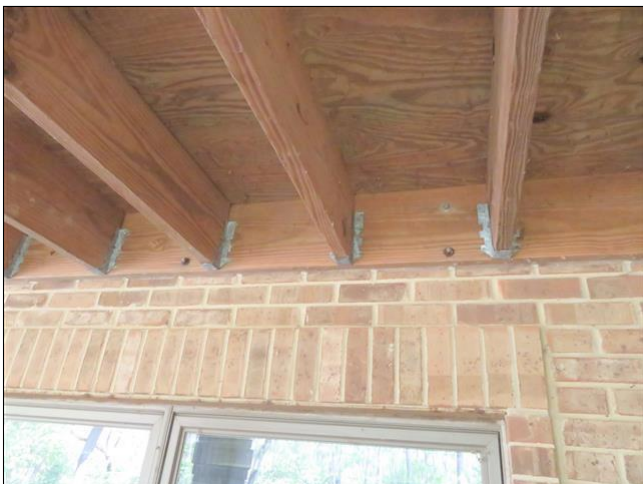
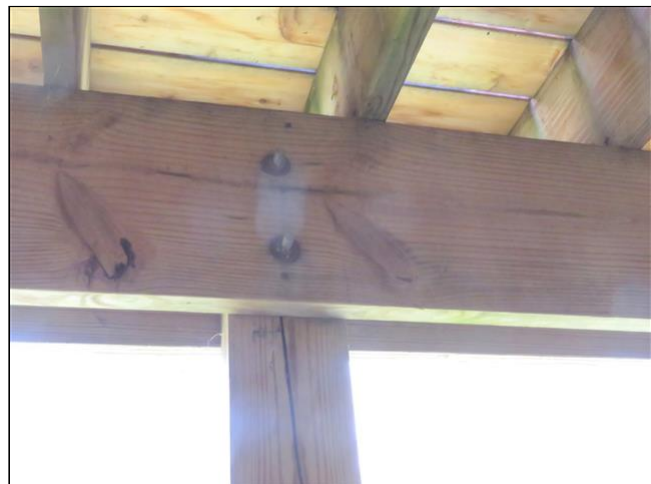
- ⏏ ♦ The deck is partially supported by attachment through the brick veneer wall. This is a common practice that has been approved by many building departments until recently. In many cases this performs as intended. However, this type of attachment has been found to be prone to concealed water intrusion. Also, since brick veneer is non-structural, there is increased risk of the brick coming loose. This is particularly a concern for tall and or large decks as well as decks where groups are entertained. We suggest having sealed and resupported as needed.

The decking is also supported by a type of beam connection that may be prone to failure. Wood joists are fastened on each side of posts. This relies on the fasteners for support rather than the lumber. We suggest having resupported to help assure proper performance and reduce the risk of damage.

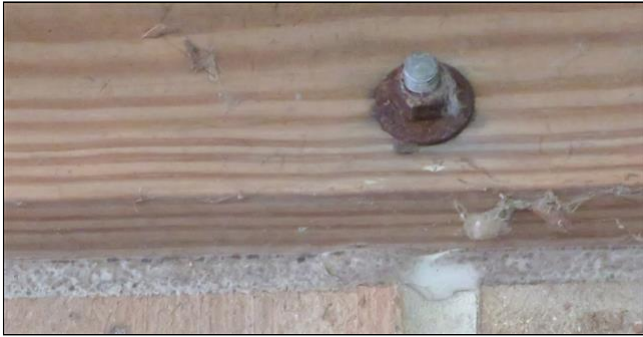
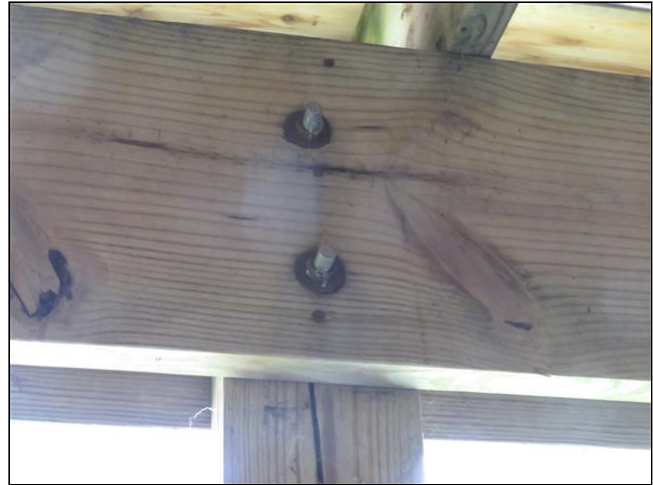
- ✘ ♦ Rusted fasteners should be replaced.

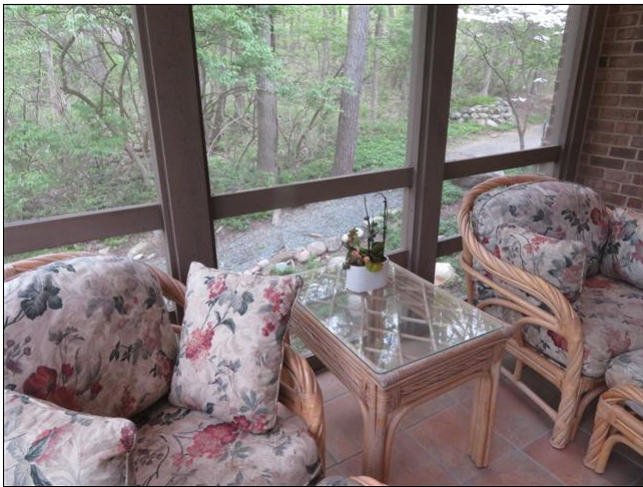
- ✘ ♦ The screened room lacks an adequate fall barrier. Have corrected as needed.

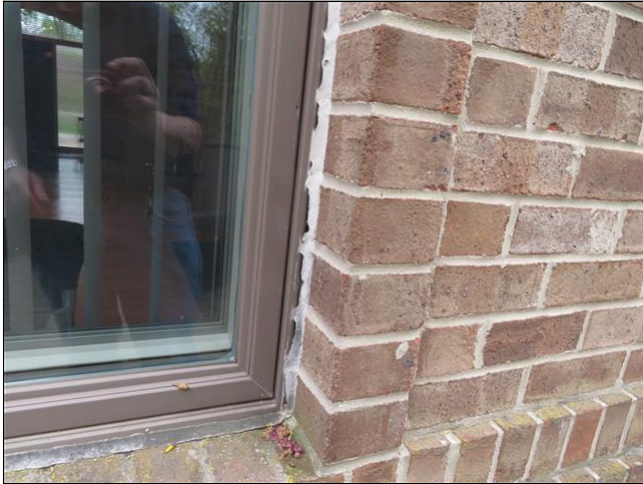
- ☑ ♦ We suggest caulking/sealing the exterior as needed to help shed water and to maximize energy efficiency. Pay attention to all openings and gaps as well as old caulk that has deteriorated.

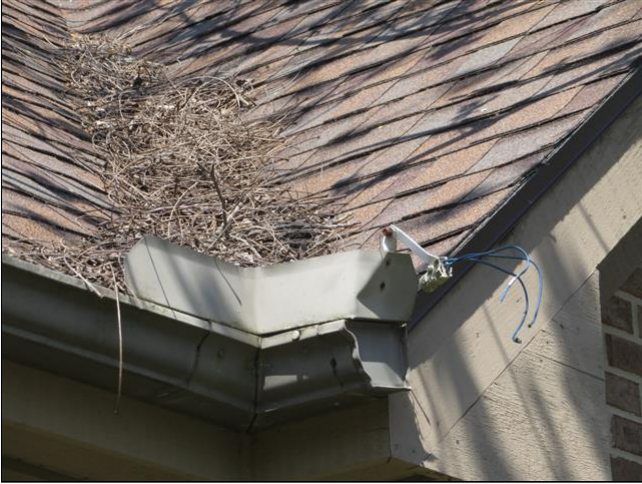
- ◆ Debris in valleys and gutters should be cleaned to reduce risk of leaks.

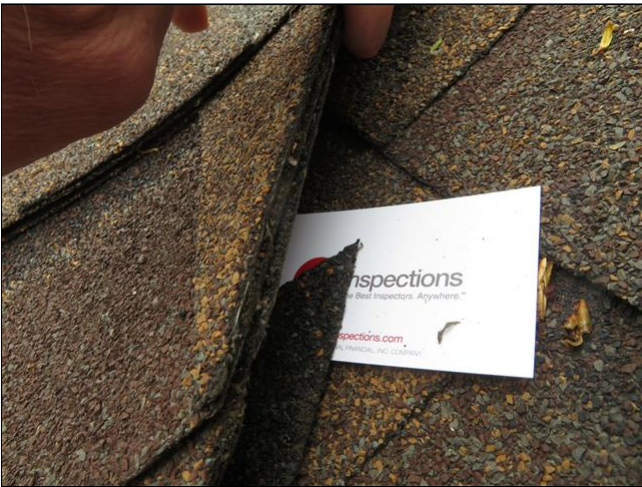
- ❖ The valley shingles were not all trimmed according to roofing specifications. The upper corner of each end shingle should be trimmed on a 45 degree angle to direct water into the valley and discourage water flow under the shingle surface. In many cases, no leaks occur, but as a precaution, we advise having corrected to help shed water.

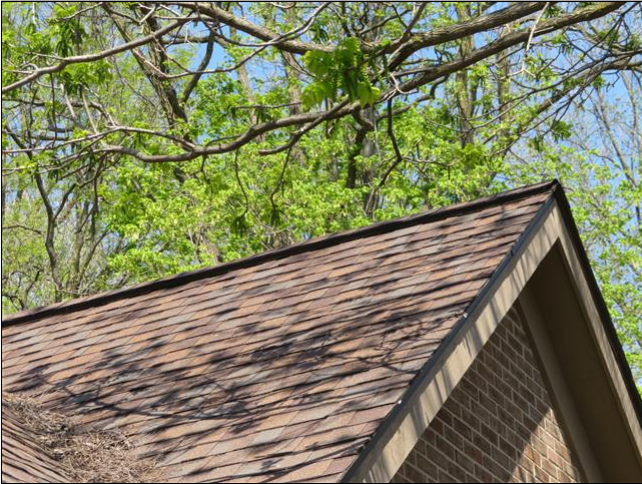
- ❖ Vegetation should be trimmed away from the roof as it can damage the roof surface and structure.

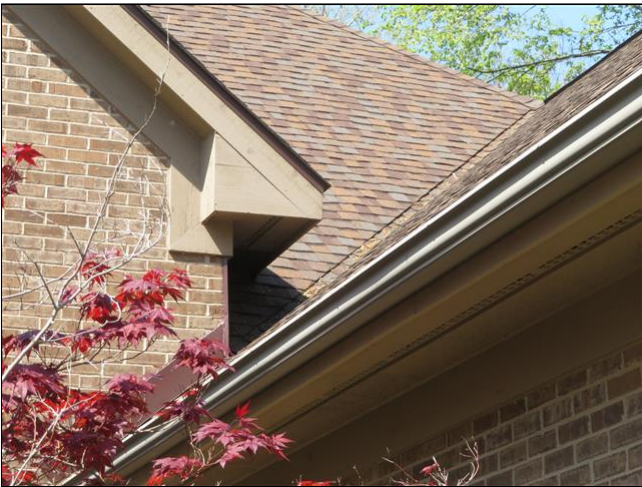
- ◆ Areas where the roof slopes towards the structure are prone to water intrusion and ice damming and should be monitored closely for leaks and maintenance as needed. Leaks might not be apparent except when actually occurring. Because of the nature of construction, important portions of the flashing are concealed from view

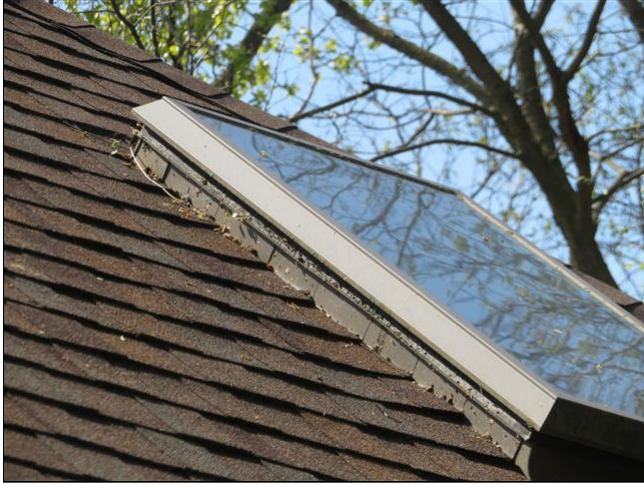
- ◆ Step flashing visible around the roof window curb. Underlayment flashing can't be verified without removing shingles so could not be verified.

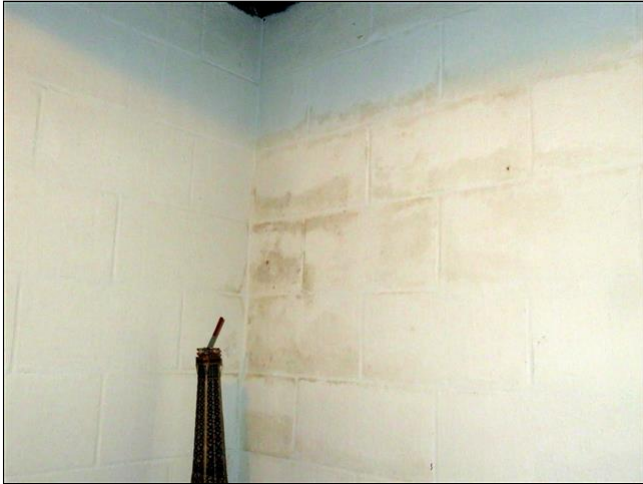
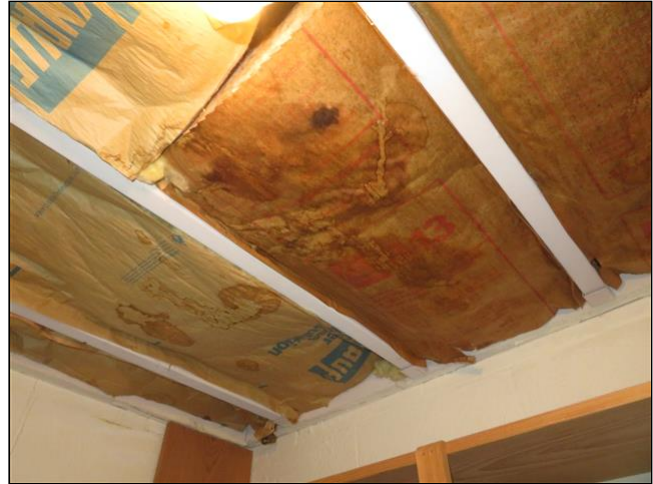
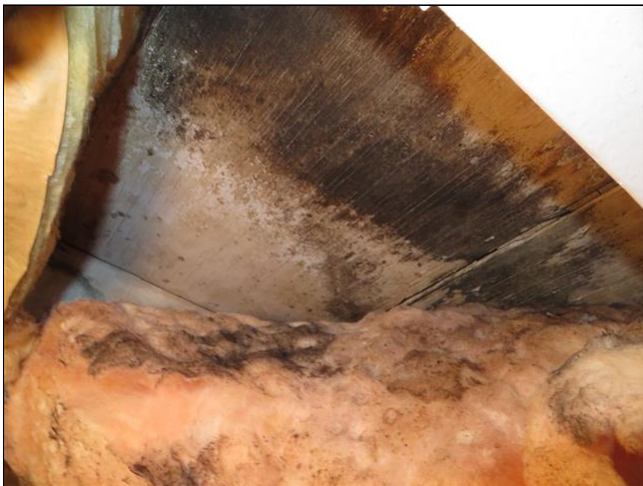
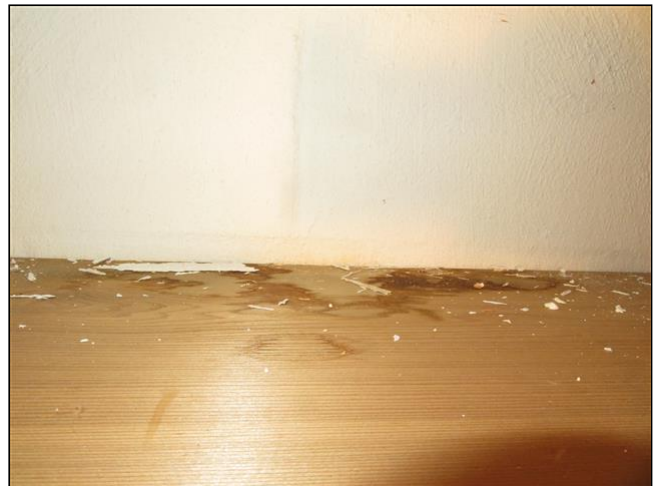
- ❌ ♦ Some water stains noted on the foundation wall in the train room as well as at the ceiling under the front porch where mold was also found. We advise having reviewed and corrected as needed.

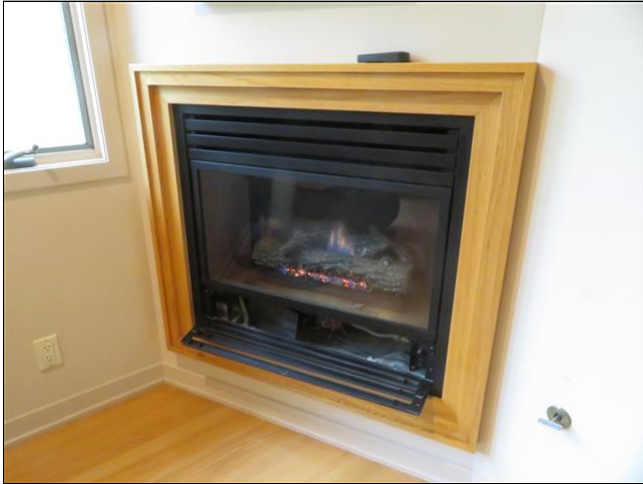
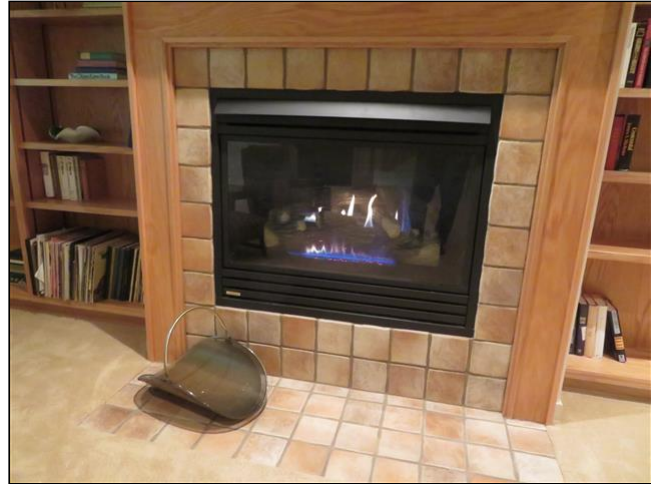
- ❌ ♦ We suggest installing a spark arrestor and rain cap on the each chimney flue. This helps prevent water and pest intrusion.

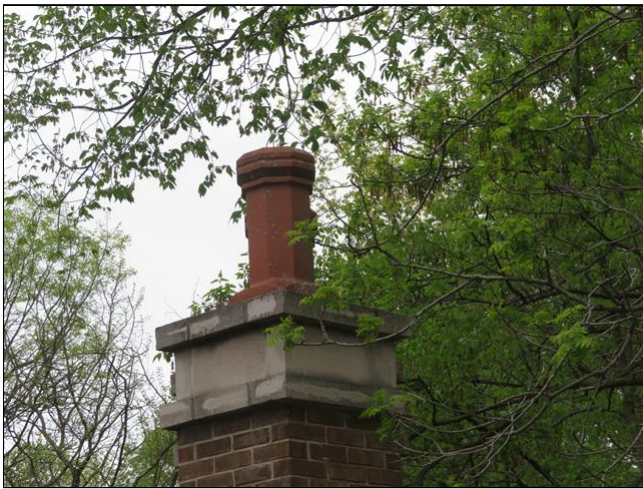
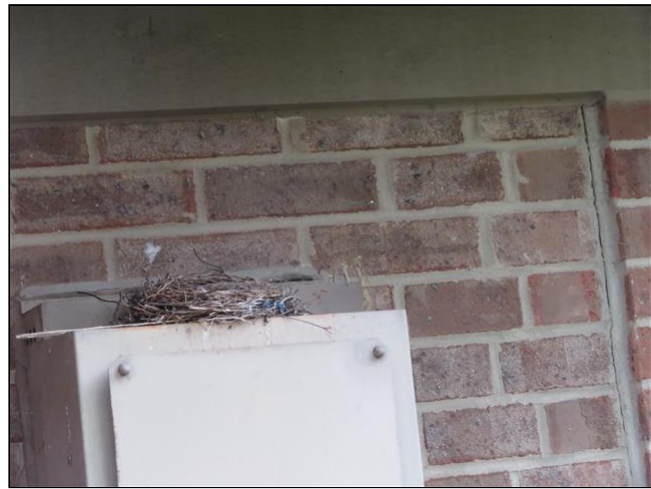
We suggest trimming vegetation well away from the structure to provide free airflow, and proper draft and to reduce chances of damage and allow for routine observation and maintenance.

One of the gas fireplace vents has an active bird nest. Have the vents cleaned before use by a qualified fireplace specialist to reduce risk of carbon monoxide entering the structure.

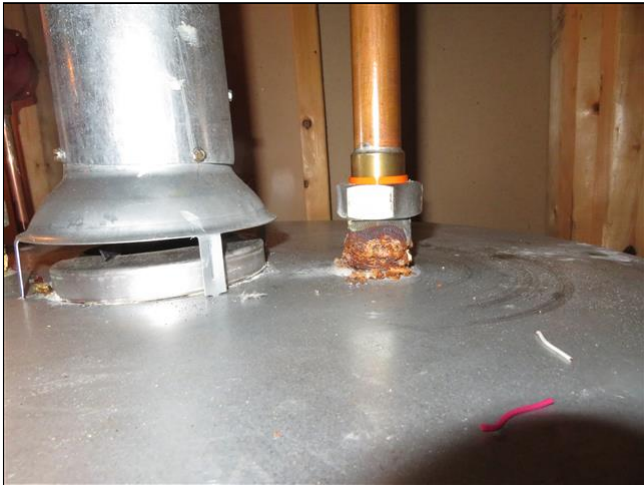
- ✘ ◆ Corroded plumbing over the tank should be repaired to prevent leaks and further damage.

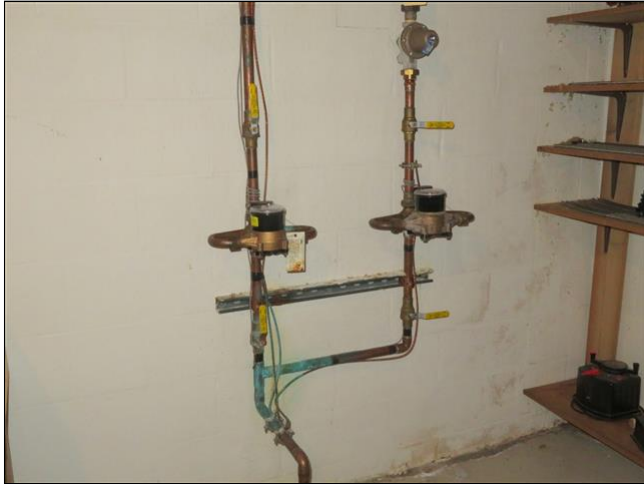
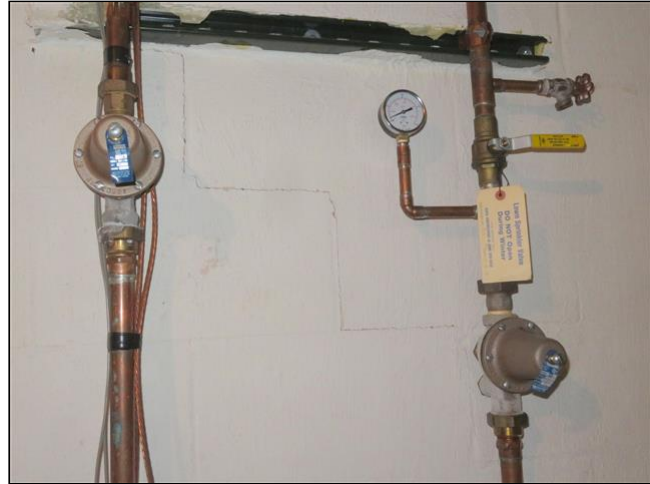
- ☑ ◆ Corroded plumbing should be cleaned and checked for needed maintenance.

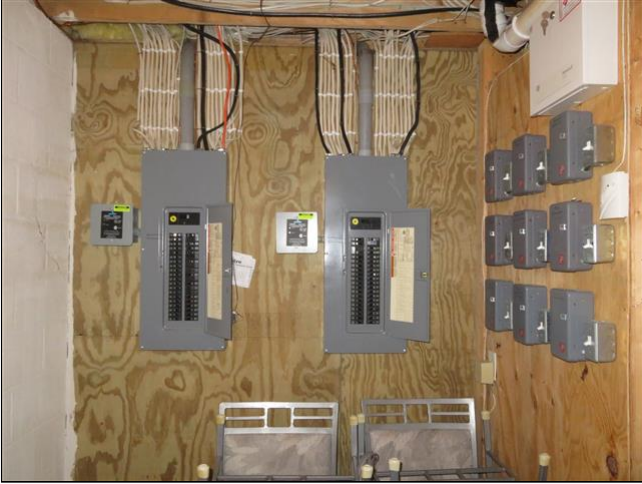
1	BASEMENT	STEAMER	0
	FREEZER		
3	LAUNDRY	STEAMER	4
	IRON		
5	FLOORS	Spine	6
7	FLOORS	Washer	8
9	LOWER LEVEL	AIR	10
	BATH	CONDITIONER	
11	UP	AIR	12
	FURNACE	CONDITIONER	
13	FOYER LIGHTS	Daylight	14
15	FOYER LIGHTS	Daylight	16
17	FURNACE	KITCHEN	18
	Room LIGHTS	OUTLETS	
19	OFFICE	AIR	20
		CONDITIONER	
21	OFFICE	AIR	22
		CONDITIONER	
23	OFFICE	MASTER BATH	24
		HEAT	
25	LANDSCAPE	Dining Room	26
	REAR	Outlets	
27	LANDSCAPE	Furnaces	28
	REAR	Door Openers	
29	GARAGE	DISPOSAL	30
	HEATER		
31	GREAT	ALARM	32
	Room	LOWER LEVEL	
33	GREAT ROOM	FURNACE	34
	MASTER BED	TRAW ROOM	
35	MASTER	LIGHTS / DE ARM	36
	BATH	GARAGE	
37	MASTER		38
	BATH	FAMILY ROOM	
39	MASTER		40
	BED ROOM	SUN ROOM

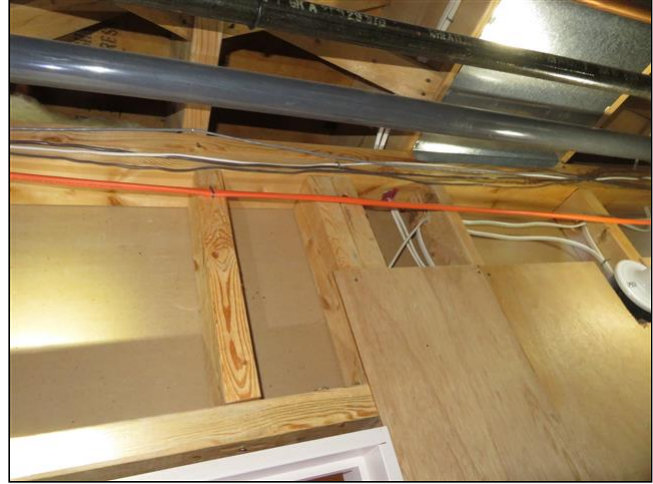
- ♦ The GFCI outlets at the porch and patio would not trip. GFCI's are an important and, fortunately, inexpensive safety device. Repair or replacement by a qualified person is needed.

- ♦ Exposed wiring at the basement should be corrected as needed and protected from physical damage to help assure safe function.

We were unable to activate the fan/light in the master bedroom.

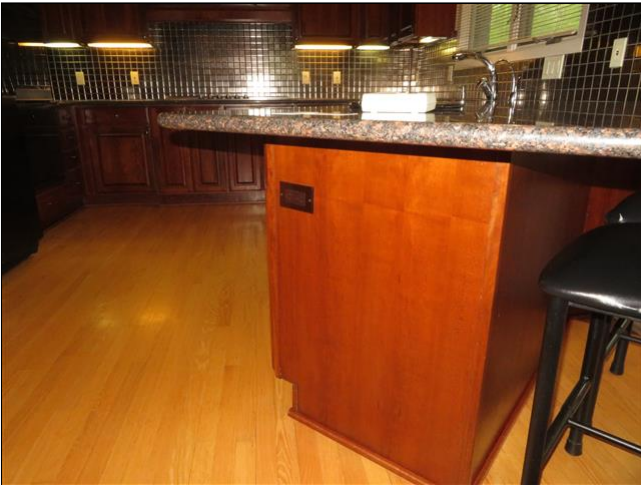
♦ Outlets under countertops can be a hazard when corded appliances are plugged in and dangle over the counter. We suggest covering the outlet or at least not using this outlet for any counter mounted appliance.

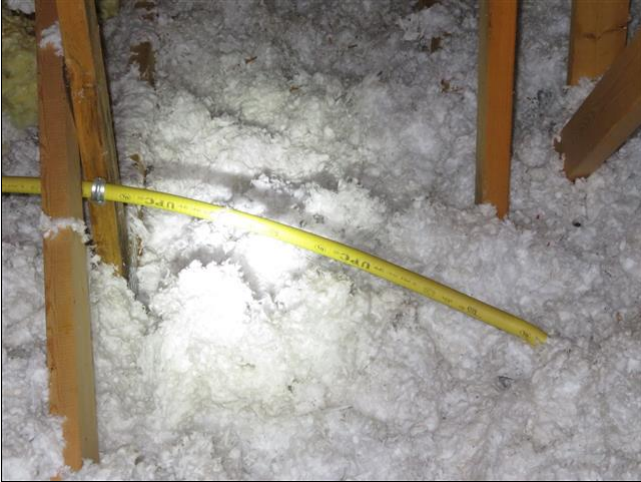
♦ The corrugated stainless steel tubing (CSST) should be bonded to the electrical service grounding electrode system. This is a fairly recent requirement in order to reduce the chances of a natural gas leak or fire. More information is available here <http://www.csstsafety.com/CSST-solution.html> or by searching the web for "CSST Bonding". In most cases, bonding is relatively easy to achieve.

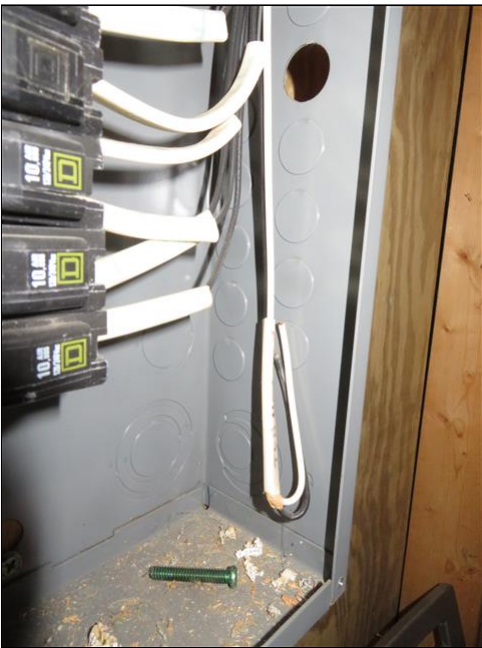
- ❏ Open knockouts should be appropriately sealed for safety and to help prevent pest intrusion. Plugs are typically widely available and inexpensive. Cut off wiring should be properly terminated with wire nuts.

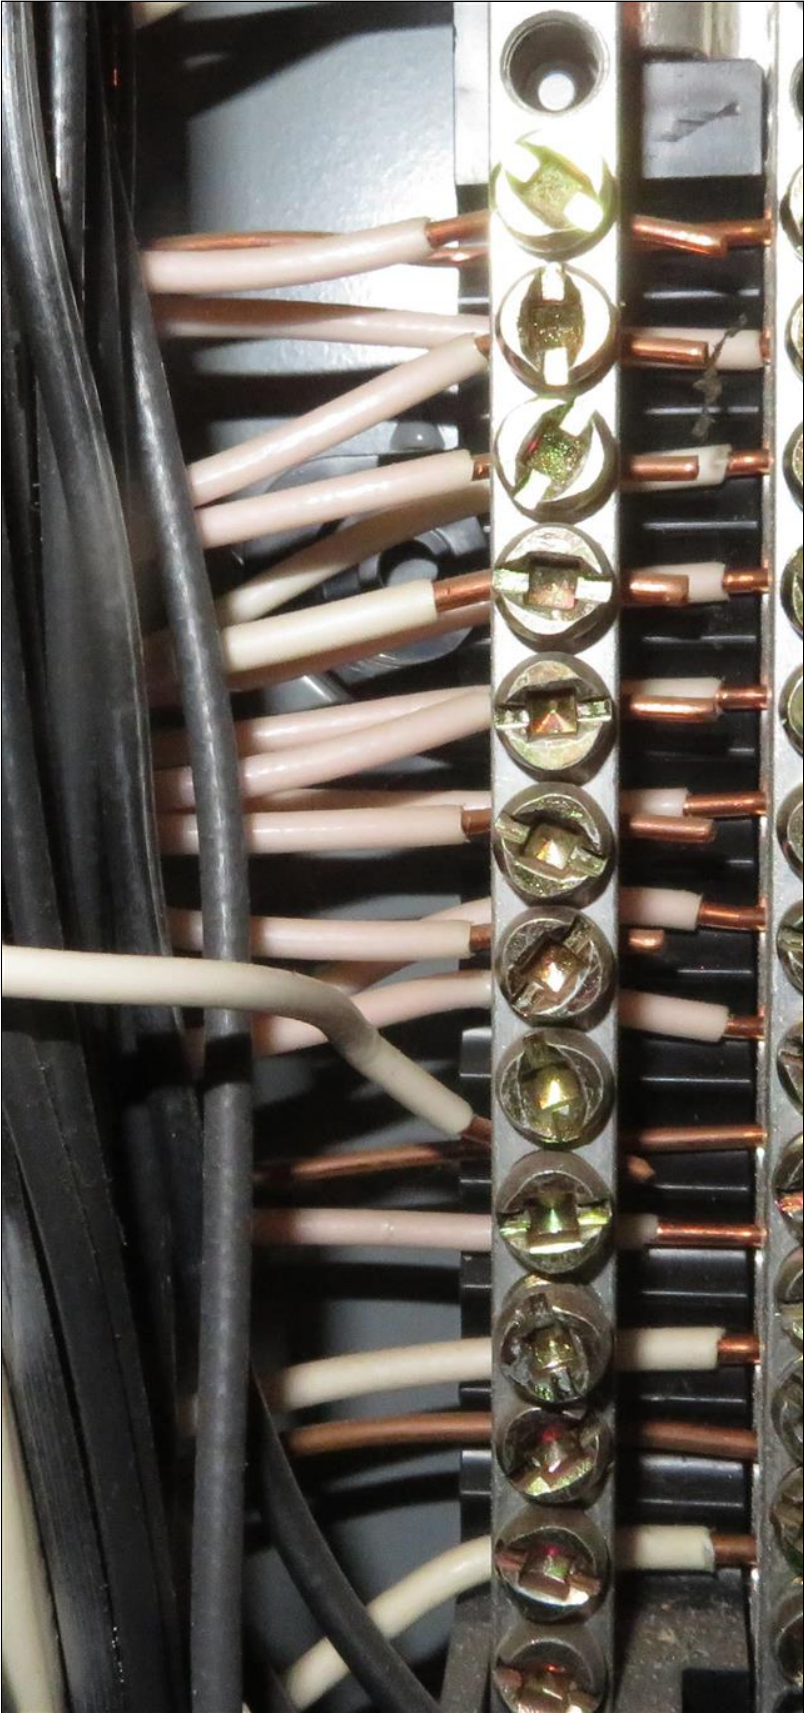
- ❏ In the left basement service panel, some grounding wires have been improperly attached to the neutral bus. Have an electrician correct for safety. This is an easy but important repair.

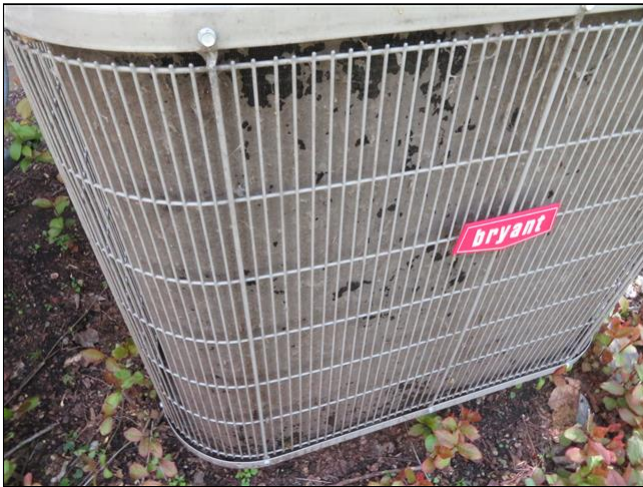
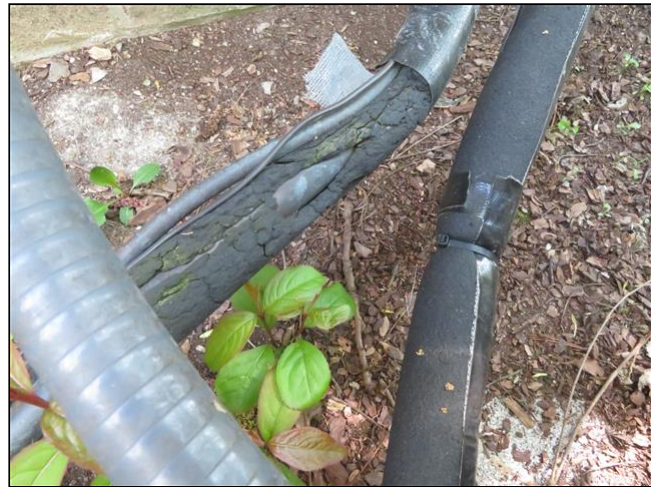
The insulation on the suction line is deteriorated at the outside unit. Missing insulation on a suction line can cause energy loss and condensation. New insulation should be installed. This is an easy repair.

Vegetation should be trimmed at least two feet away from the exterior air conditioning unit(s) to avoid excess wear and increase efficiency.

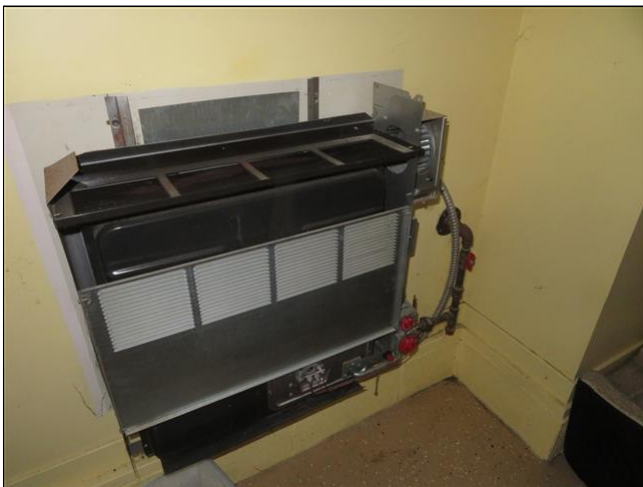
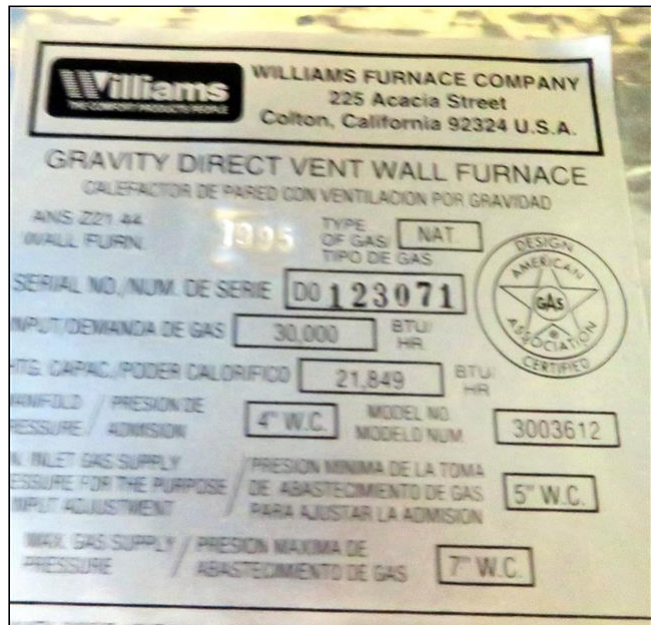
- ☒ ♦ The furnaces and one air conditioner are old and could require repair or replacement at any time.
- ☒ ♦ We were unable to light pilot on wall heater in garage and suggest having serviced by a qualified heating contractor.

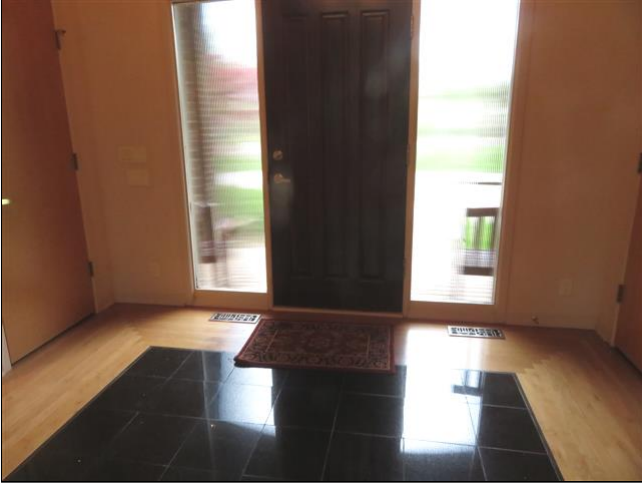
- ◆ There is no safety glass label visible at the windows by the entry door. If the glass can not be verified as safety glass we advise having upgraded as a safety enhancement.

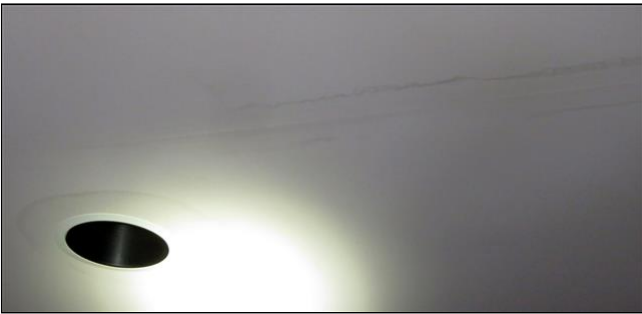
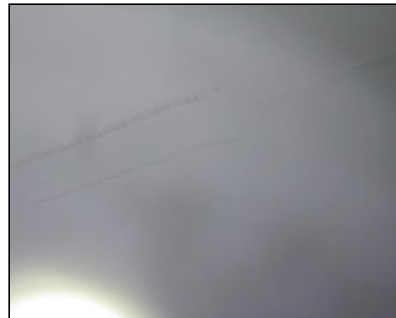
- ♦ Water stains are visible on the basement ceiling, under the master suite. We suggest having the source of water determined and repairs made as needed. Note that the steam unit was not tested during the inspection as the breaker was shut off.

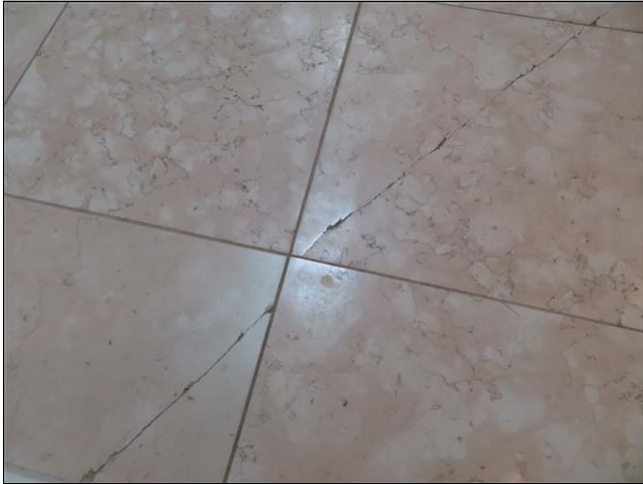
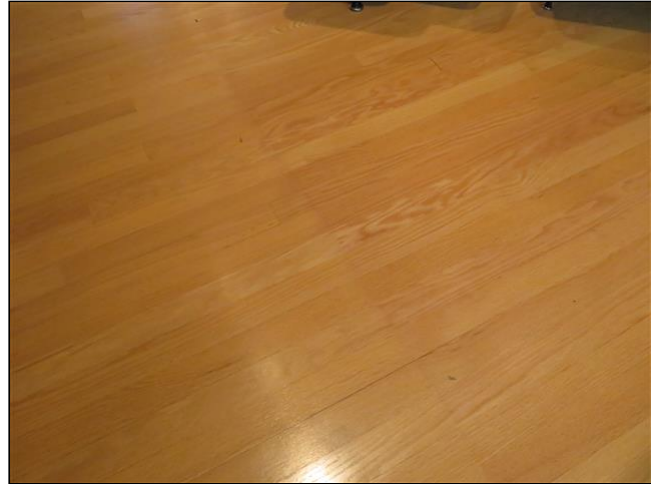
- ♦ Some thin tile cracking noted and areas of cosmetic damage at wood floors.

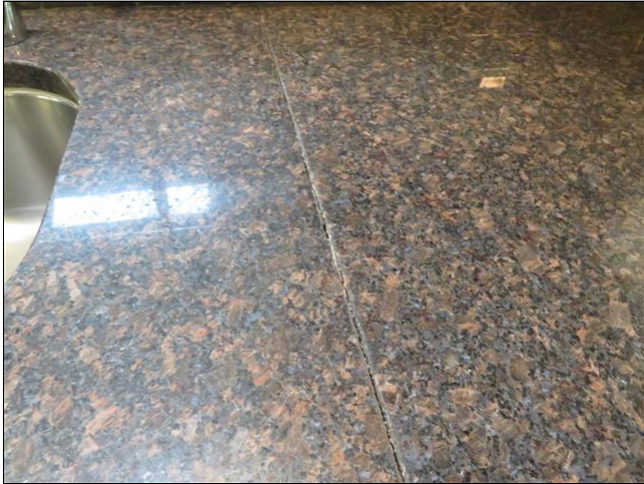
- ⬆ ◆ Gap needs sealing.

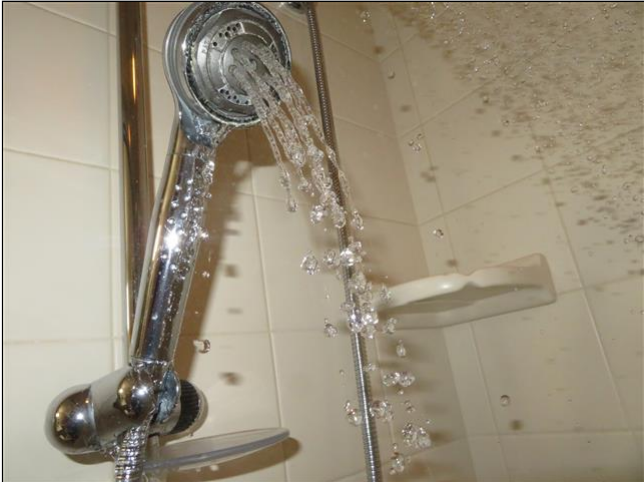
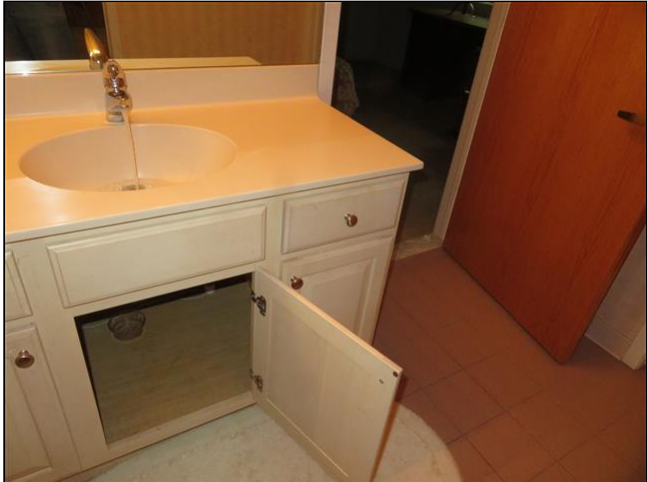
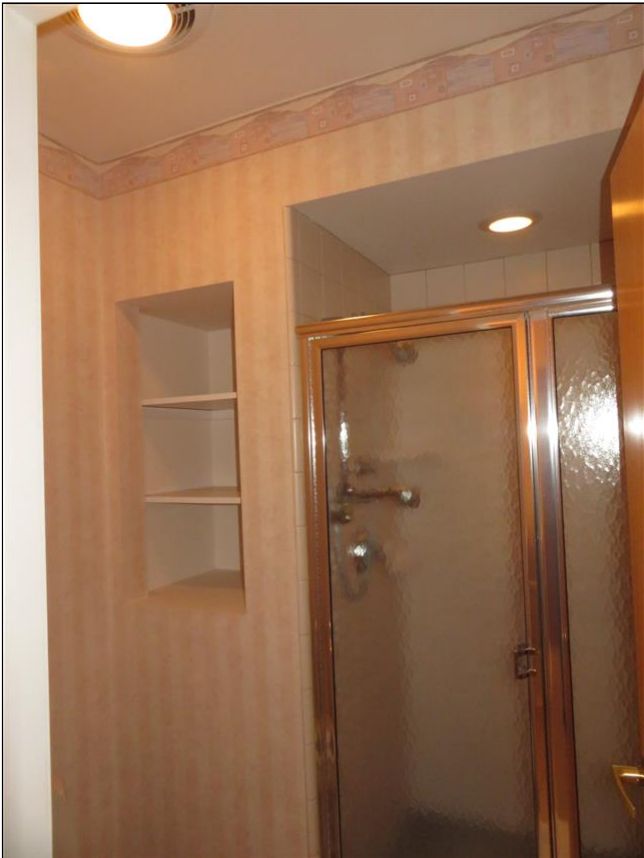
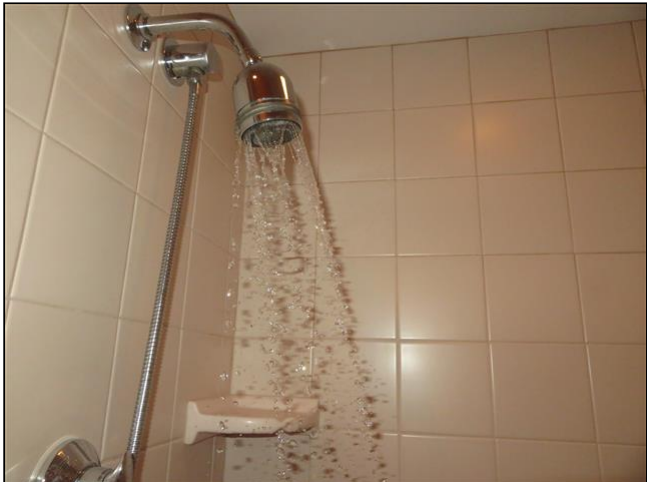
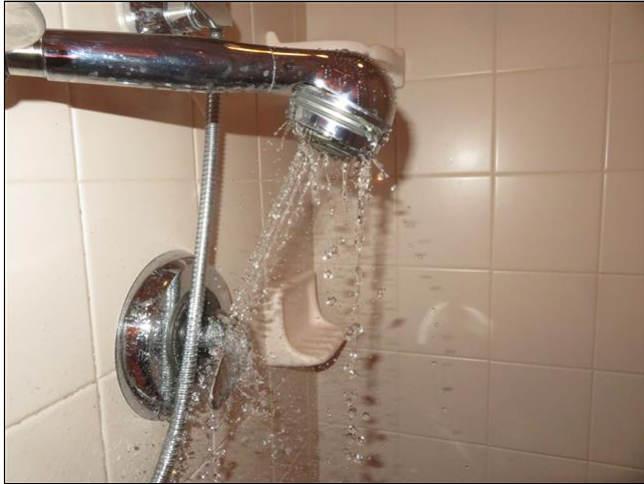
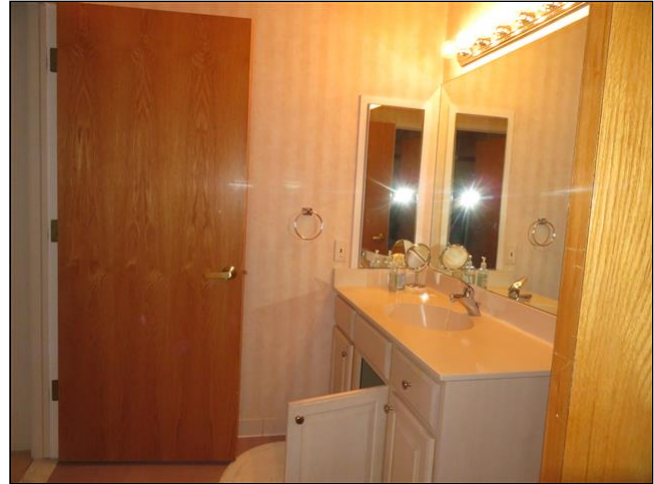
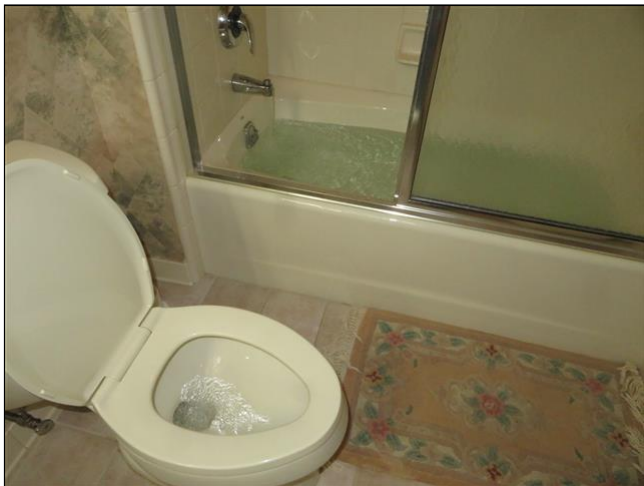
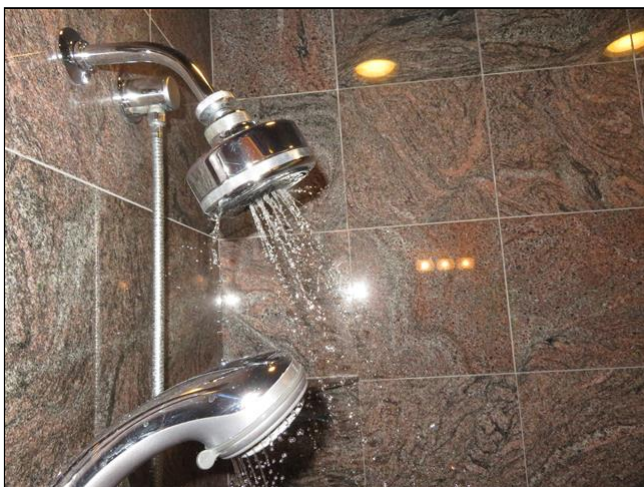
- ♦ The shower diverter at one of the basement baths is difficult to operate and needs repair.

- ☒ ◆ Tiled shower pan(s) noted; we are unable to confirm the integrity of the concealed waterproofing liner. A definitive test for leaks in a tile shower base requires two to three inches of water left standing for up to 48 hours. There were no signs of current leaks, but this definitive test was not part of this inspection.

- ☒ ◆ Pump operable but we were unable to turn off neck jets (they have their own switch). The jets can't be turned on without spraying water out of the tub until corrected. Have adjusted/repaired as needed.

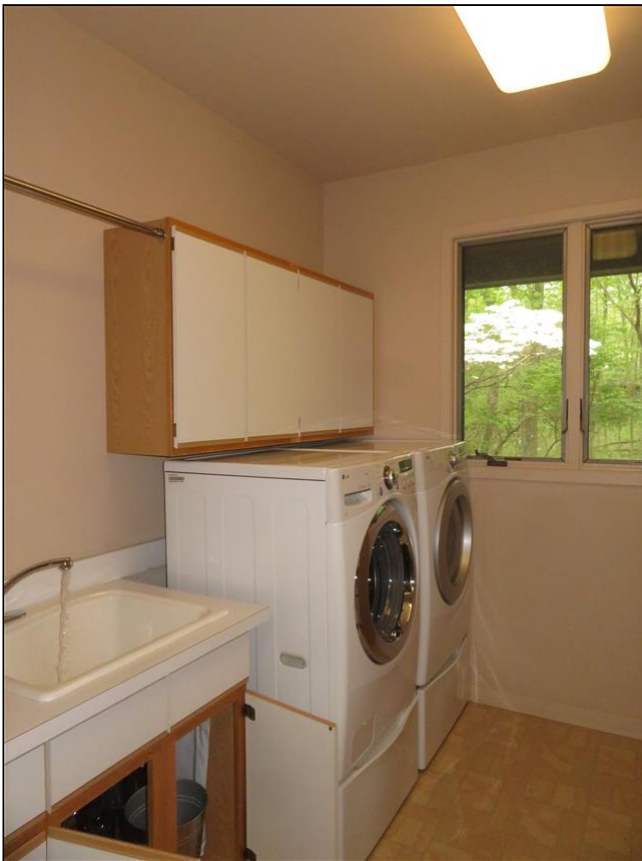
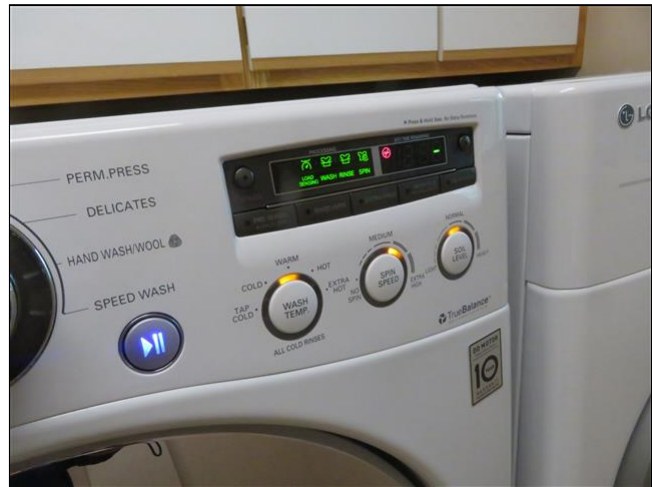
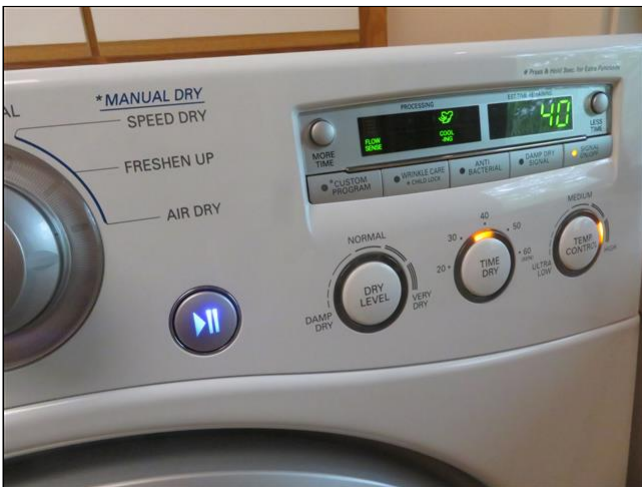
LAUNDRY PHOTO

♦ No water hammer device installed. If water hammer is experienced during use these plumbing devices will need to be installed for noise control and to help prevent leaks. This is typically an easy repair for a plumber.
